The Development of the Bure Valley Railway ZB Class

Ian Gaylor
Robert King

Rev.1
Date 4.10.22.

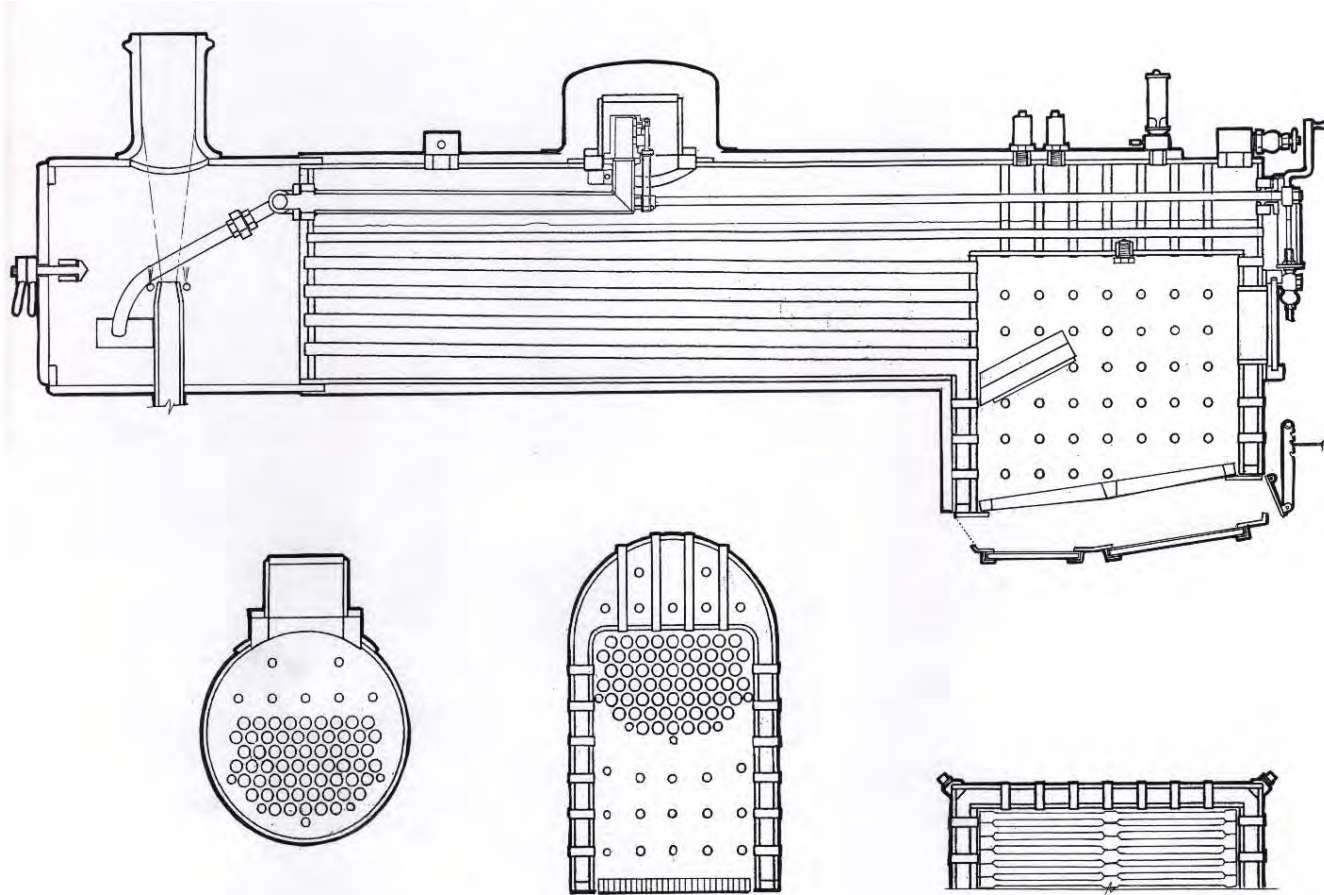
Sketch of ZB boiler as built

- The ZB boiler has proved to be very free steaming
- Some early problems were experienced with the firebox and in particular the tubeplate due to high evaporation rates and poor water quality.
- To overcome this the throat plate thickness was reduced from 20mm to 13mm to make it more flexible
- As a result of their early life the boilers of Nos. 6 & 7 have been replaced whilst that of No.9 remains in good condition

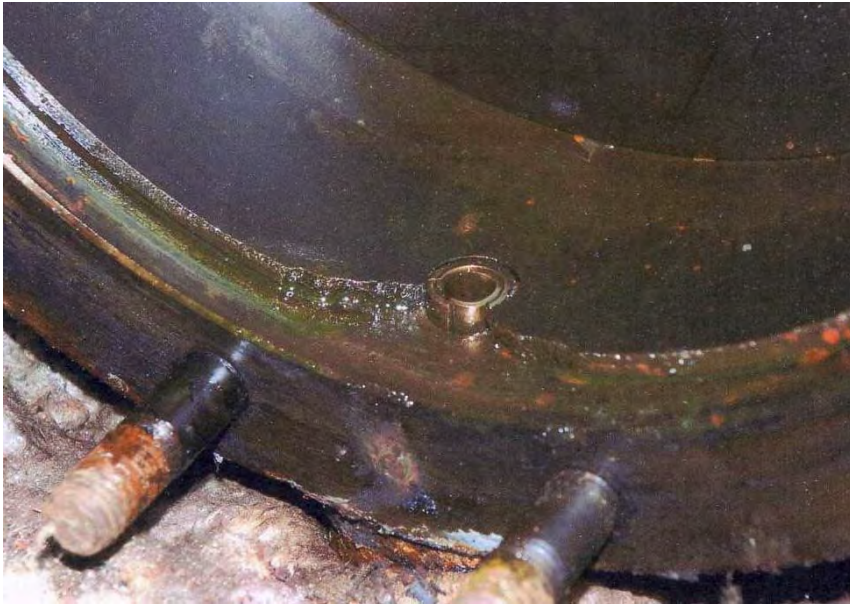
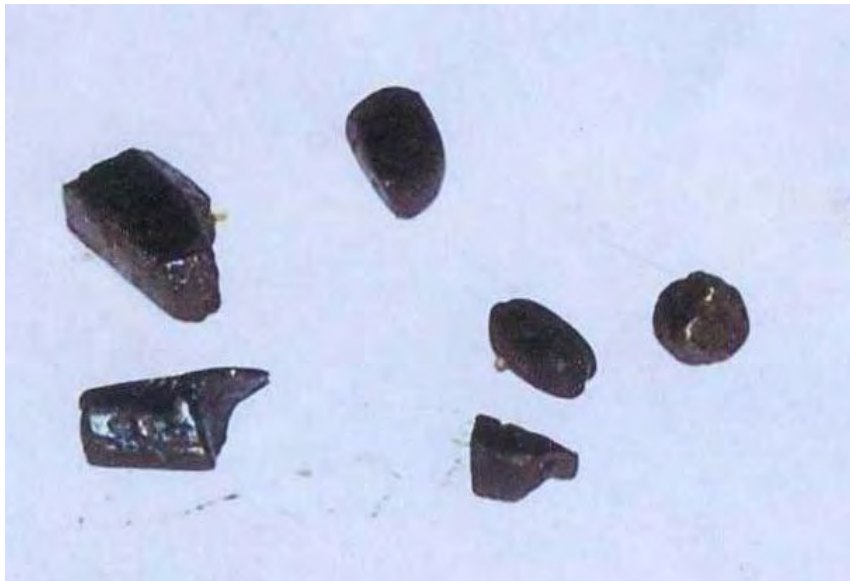
Failure of cylinder liner 'O' ring seals

- After over 20,000 miles of operation the 'Aflas' 'O' rings on both Nos. 6 & 9 which sealed the cylinder covers to the cylinder liner and the bore of the cylinder fabrication failed.
- After examining the 'O' rings it was concluded that the most likely cause of this failure was explosive decompression due to the ring surface breaking down as absorbed steam/water was violently released from within the body of the ring
- Failure of the rings then enabled the liner to move due to the alternating pressure and the load on the anti-rotation spirol pin caused the edge of the liner to fail in shear
- Subsequently the liners were refitted and a gasket based repair was designed by the workshop which has been proved to be effective in service

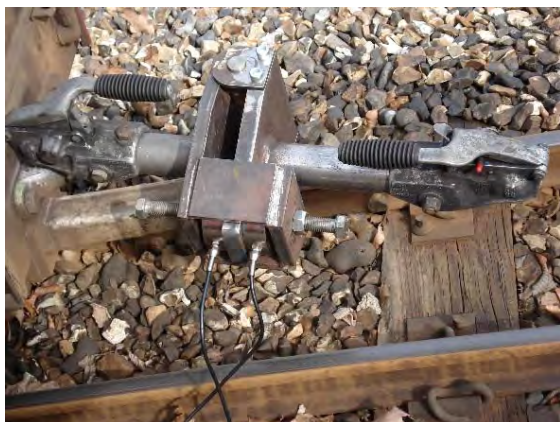
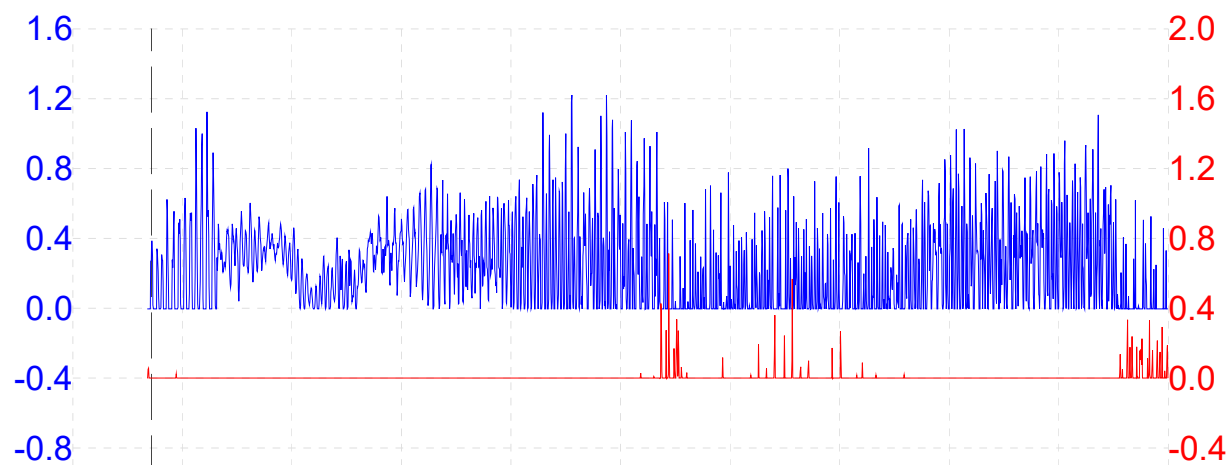
Longitudinal resonance of train – ‘Shuttling’

- There was a long-term problem associated with the ZB locomotives which create longitudinal ‘shuttling’ of the coaches within the train when the set is excited at a resonant frequency typically at around 12-15 mph.
- This is both unpleasant for passengers and has also led to fatigue failures in the ball hitches of the coupling system
- The Coupling loads were measured by experimental testing and the trace shows resonance approaching Burgh summit with a 6 coach train.
 - The blue trace is tension and the red trace is compression.
 - The vertical axes show the load in tonnes force.
 - Surging can be seen where the coach is overrunning the coupling.

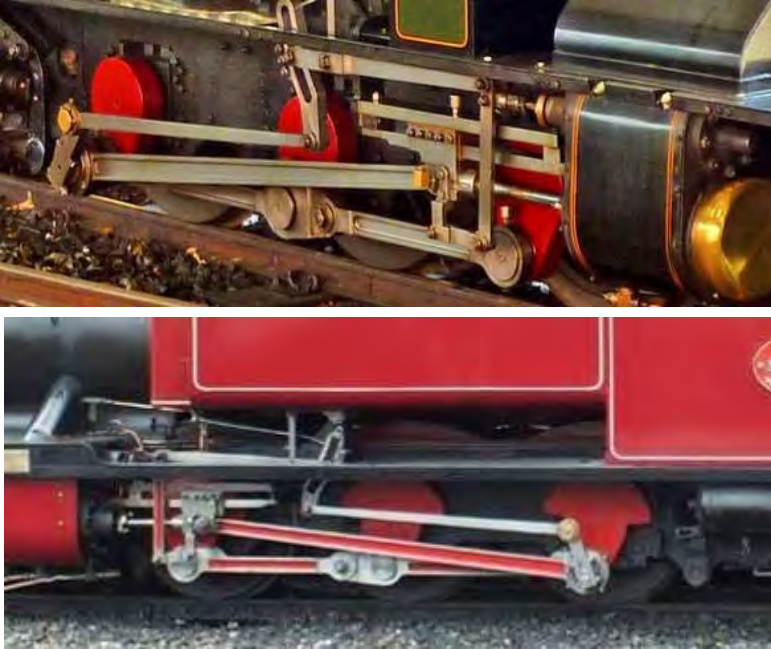
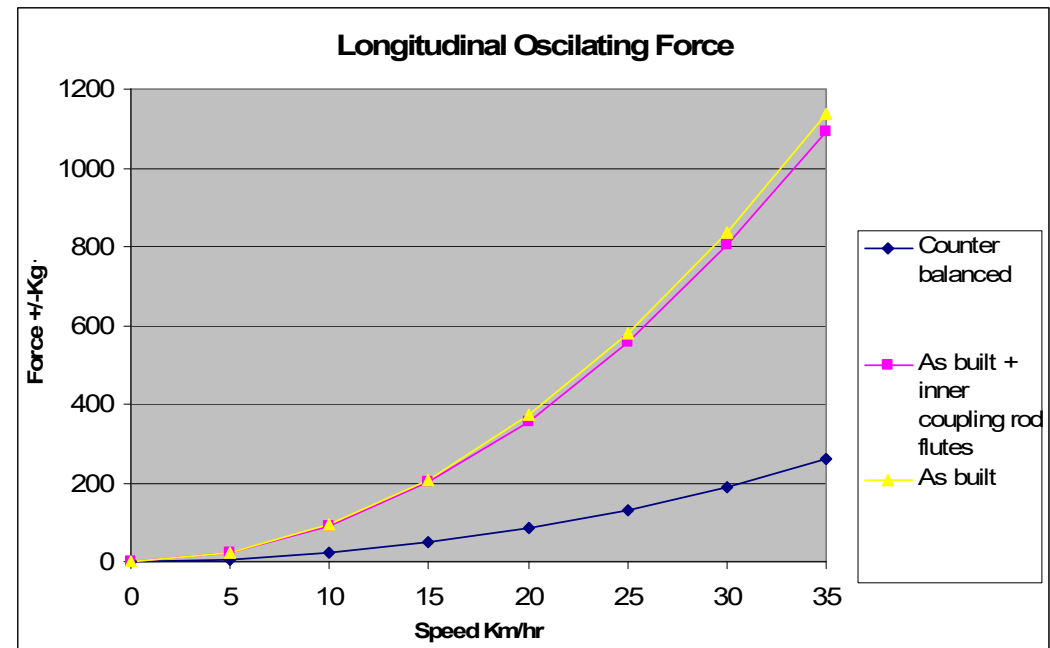
Longitudinal resonance of train – ‘Shuttling’

The ZBs were significantly unbalanced with only small counterweights on the wheels:-

- The reciprocating masses were completely unbalanced
- A significant proportion of the rotating masses were unbalanced
- As built the longitudinal disturbing force at 32.3 km/hr, 20 mph was ± 936 kg
- Counterbalancing all the rotating masses and 55% of the reciprocating masses reduced the magnitude of the pulsations by 77.3% giving a longitudinal disturbing force of ± 219 kg which has significantly improved the passenger experience

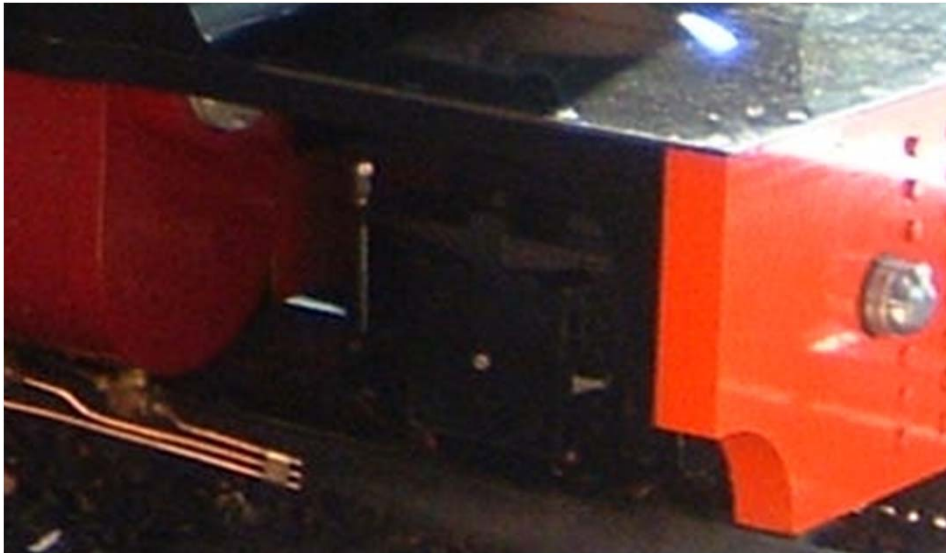
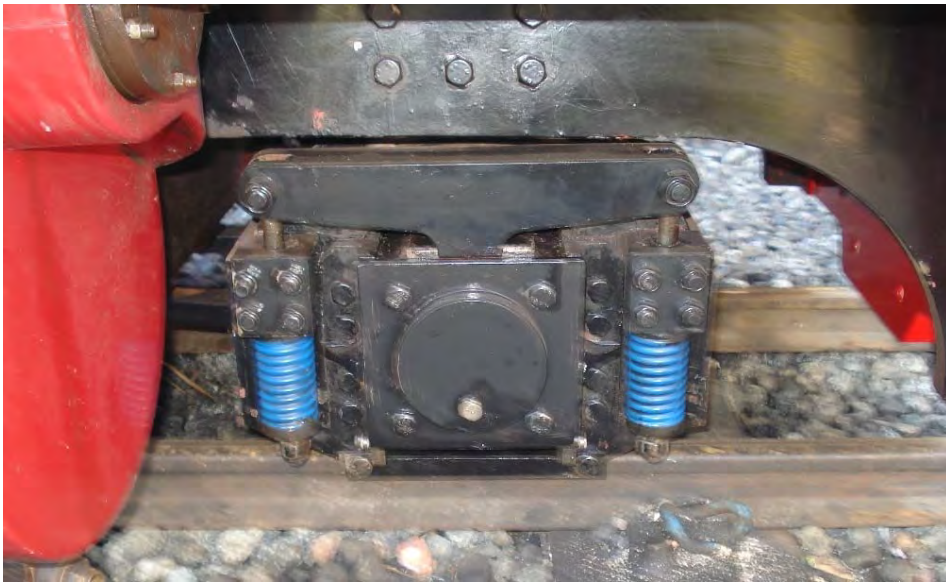
Improvements to front pony truck springing on No.9

- The original leaf springs had few leaves making them too stiff and overstressed
- This was changed to a more compliant design with a greater number of thinner leaves but the fatigue life was limited due to space constraints (see photo)
- As the locomotives are always running in the forward direction the leading truck suspension takes a pounding from the track
- The final solution was to substitute the leaf spring with a solid beam and provide a pair of die springs with the identical rate but greater fatigue life (see photo)

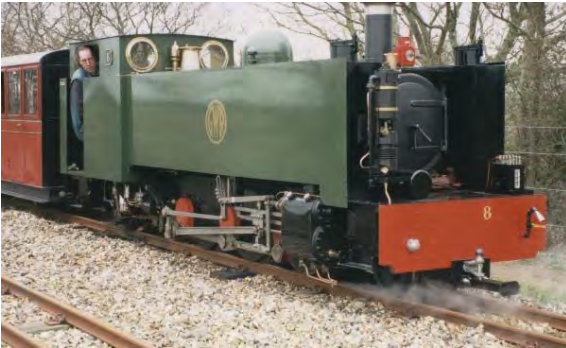
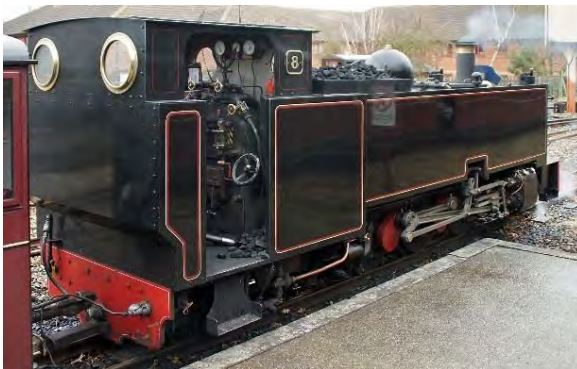
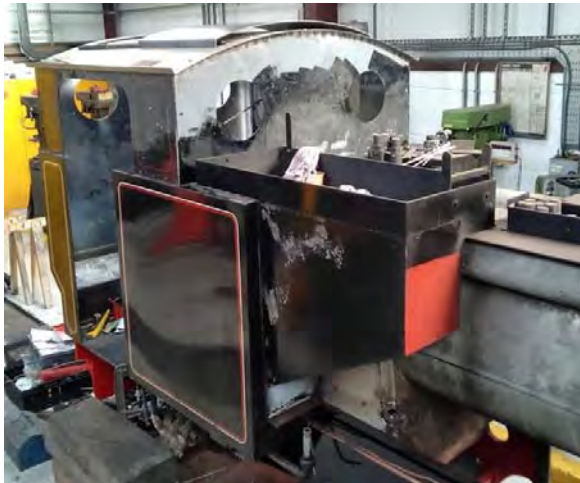
The oil firing of No.8 is improved but is finally converted to coal firing

- To reduce fire risk No.8 was built with a Weir type burner below the front throat plate firing backwards
- Steaming was poor and the Weir burner was replaced with a row of 4 burner nozzles based on industrial paint sprayer technology
- The 4 nozzles fired towards the underside of an auxiliary brickarch situated below the fire door
- Steaming was better but limited the performance of locomotive + exhaust fumes and burner 'rumble' were unpleasant for crew and passengers
- Periodically soot required cleaning from boiler surfaces
- The rising cost of fuel and the need for improved performance resulted in a conversion to coal firing
- A bunker was constructed in the former oil tank and part of water tank space
- At the same time the cab enlarged with cranked back sheet and raised roof for crew comfort

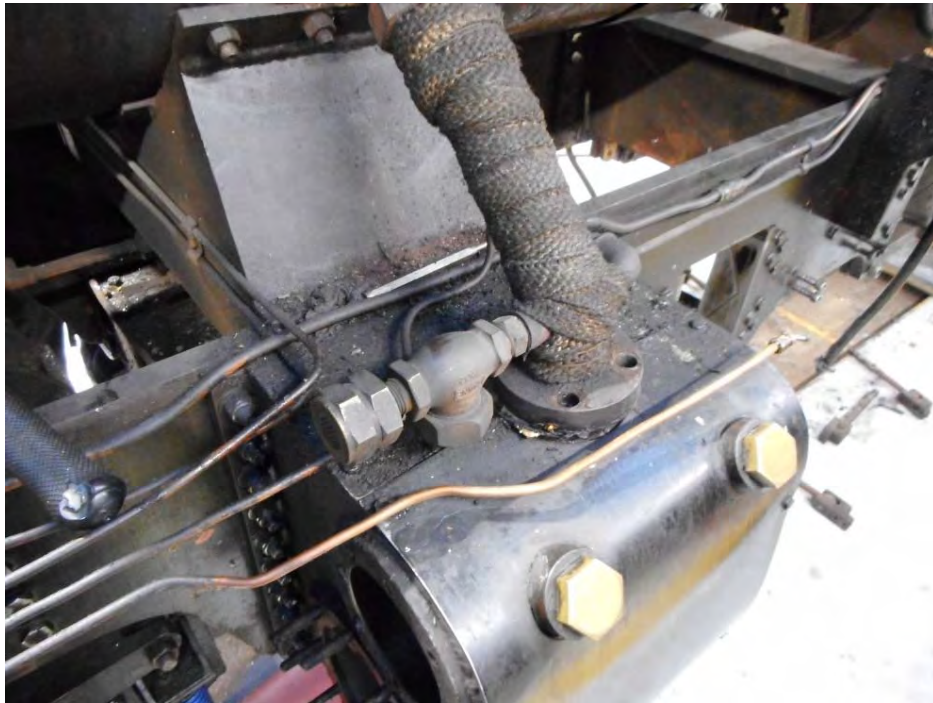
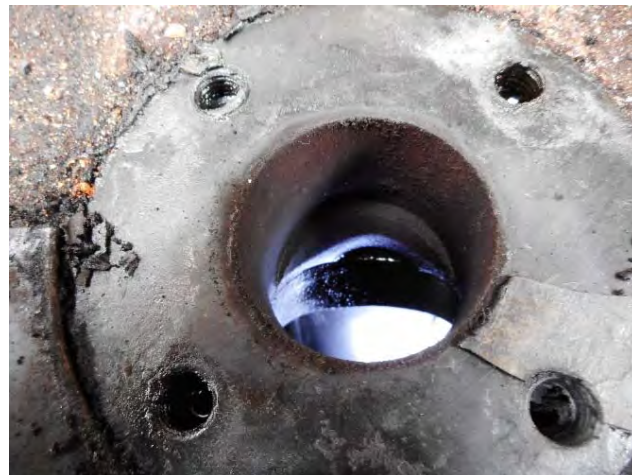
The original cylinders on Nos. 7 & 8 restricted the steam flow

As constructed: -

- The steam chest inlet, transfer ports and exhaust ports were restricted
- Steam chest volume was only 10.1% of cylinder swept volume

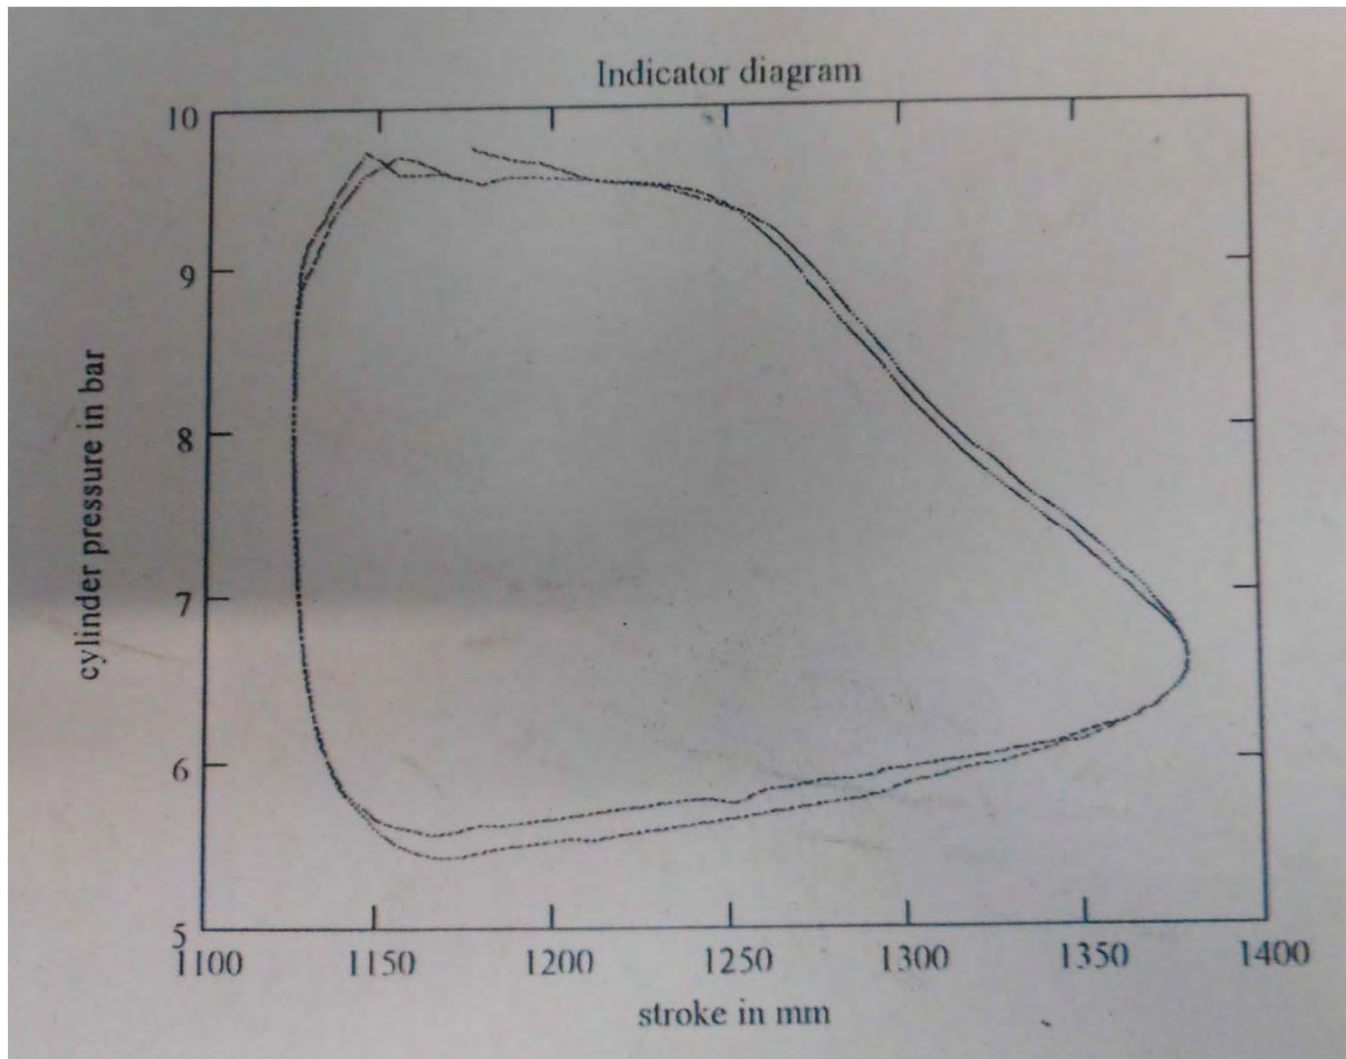
The original cylinders on Nos. 7 & 8 restricted the steam flow

- Indicator diagram of cylinders as built (with early initial solid BVR valves)
- Boiler pressure 165 psig, 55% cutoff, speed 13.4 mph
- Note the exceptionally high back pressure

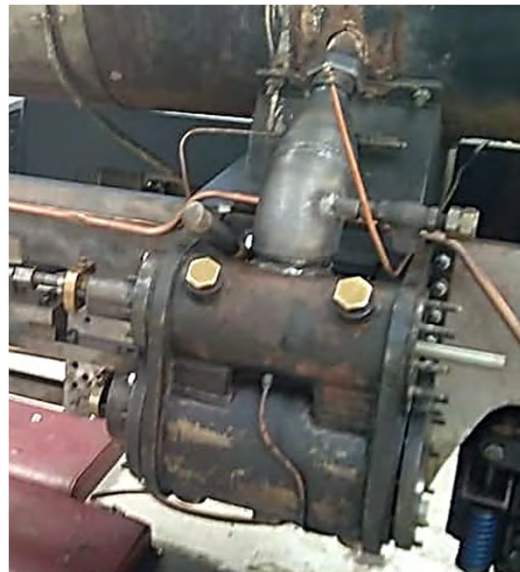
The original cylinders on Nos. 7 & 8 were improved

- The cylinders were probably designed for ease of manufacture and steam flow has not been optimised
- The cylinders were not stress relieved before machining when manufactured and are therefore prone to distortion (see joint with mainframe)
- Steam chest inlet and transfer ports were opened up by die grinding to increase steam flow however the transfer passageways remain 'Z' shaped
- Steam chest volume was increased by welding on large diameter pipe fittings in order to ensure a full indicator diagram at speed
- The exhaust ports remain restricted as the steam has to pass around 3 x 90° bends before reaching the pipe to the exhaust stand

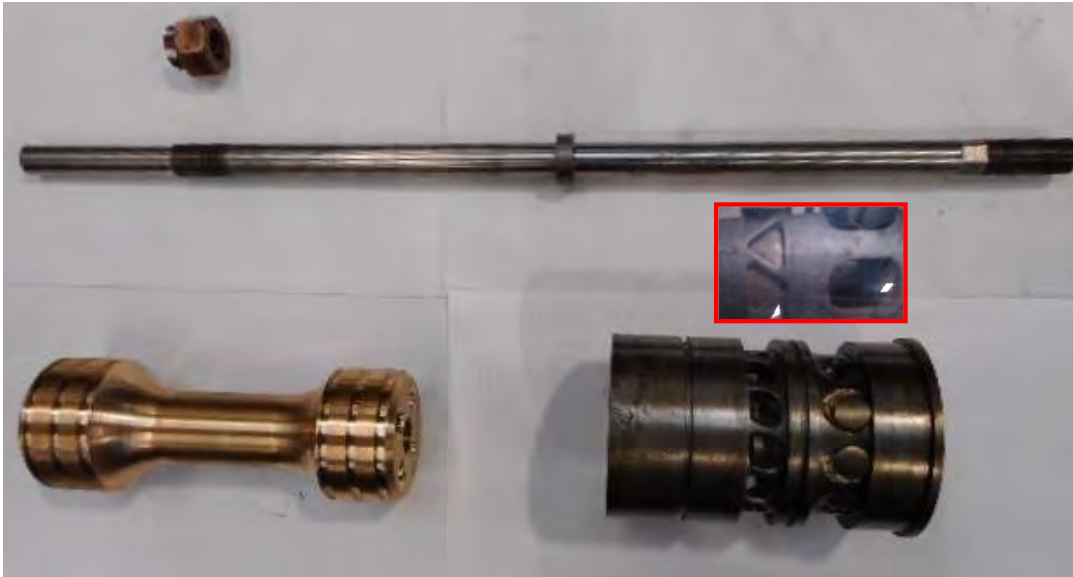
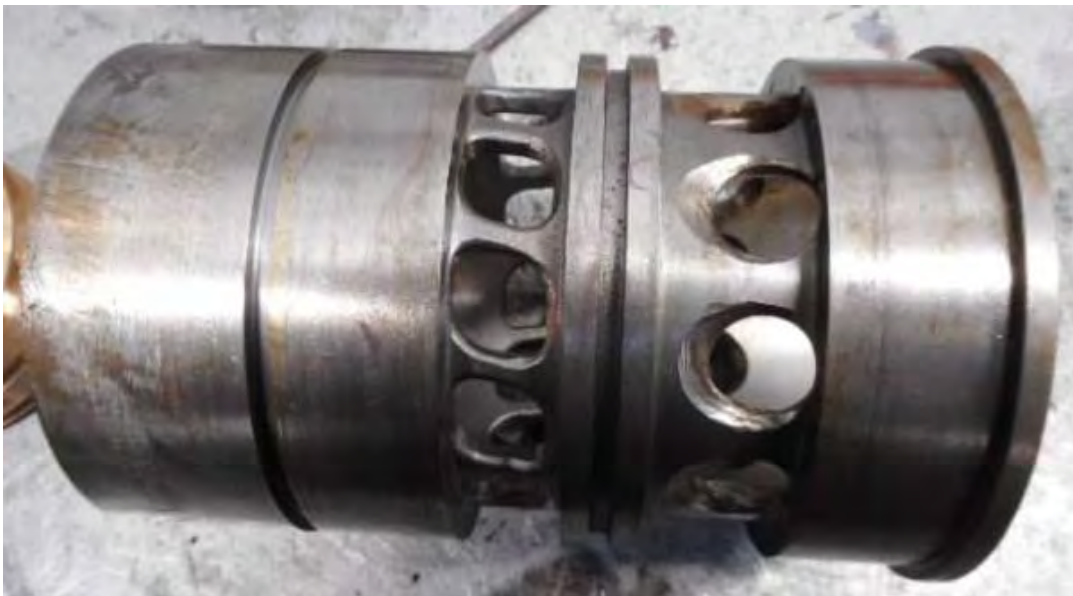
New valves and liners were fitted to the improved cylinders

- New split cast iron valve liners have been manufactured with a bore of 76mm, 3".
- Annular recesses are provided on the outside of the liner to enable the ports in the fabrication to; -
 - Align with the exhaust ports which have been moved outwards to accommodate the increased valve lap
 - Ensure that the transfer ports better connect with the transfer passageways
- Port areas have been increased and transfer port shape is improved for better admission at short cut offs
- A hollow bronze valve for improved exhaust flow features increased steam and exhaust laps with 3 x Clupet rings on each head
- A cylinder liner of 165mm, 6.5" bore is provided to reflect the reduced valve diameter

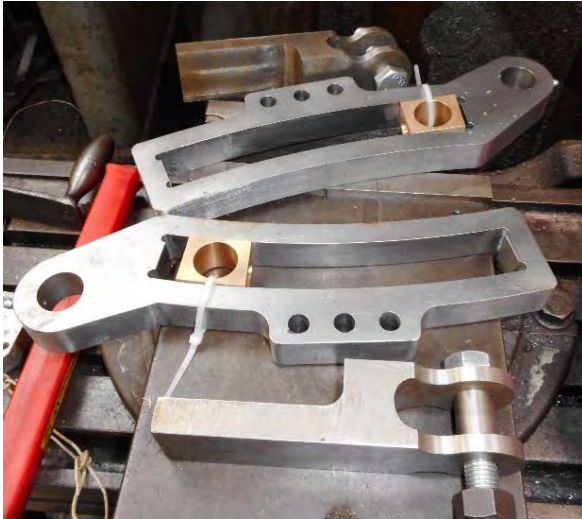
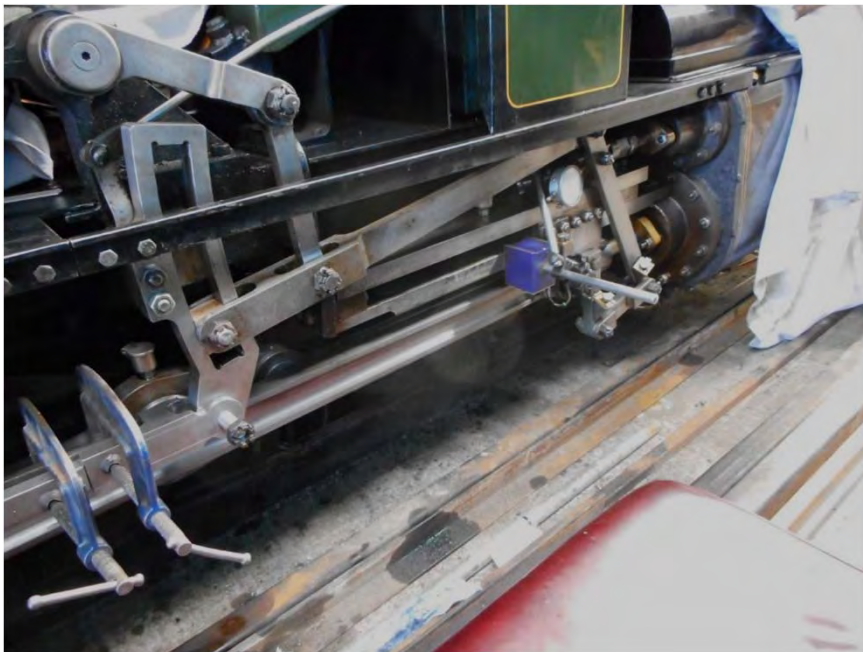
Valve gear improvements were made to Nos. 7 & 8

- The valve gear was redesigned to increase valve travel and therefore port openings for better steam flow which entailed:-
 - New expansion links with longer die block slots and shorter drop arms
 - New combination levers
 - Modifying the length of the eccentric rods to suit the new geometry (as shown in the photo)
 - Recalibration of the reverser scale to suit

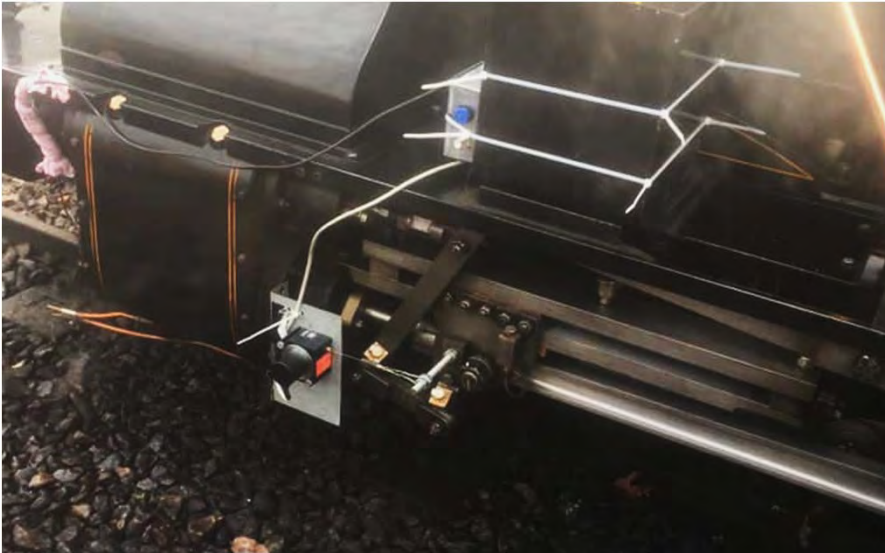
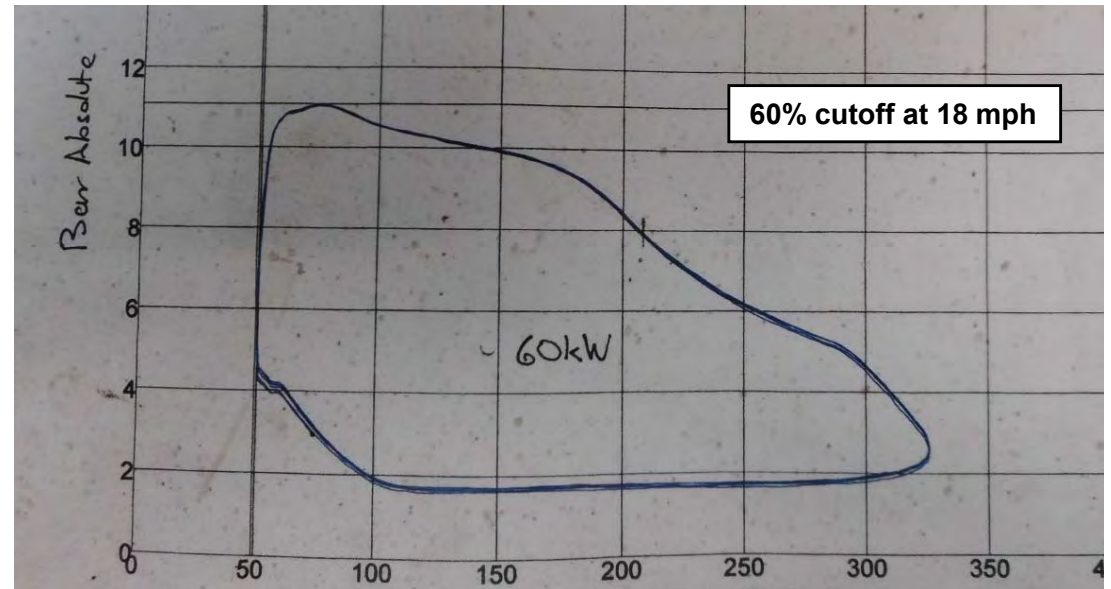
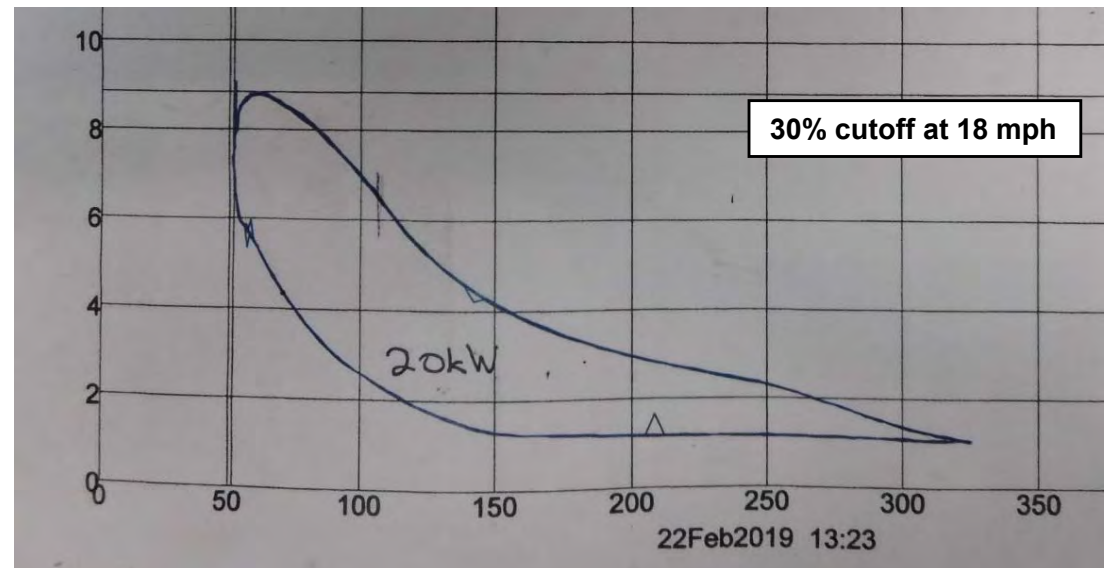
Prior to increasing the steam chest volume indicator diagrams were prepared

- Indicator diagrams were recorded digitally using pressure transducers and a liner transducer to measure crosshead position
- Poor filling of the cylinder during admission is thought to be due to lack of steam chest volume
- Subsequent increase in the steam chest volume has significantly increased power and it is planned to record fresh indicator diagrams

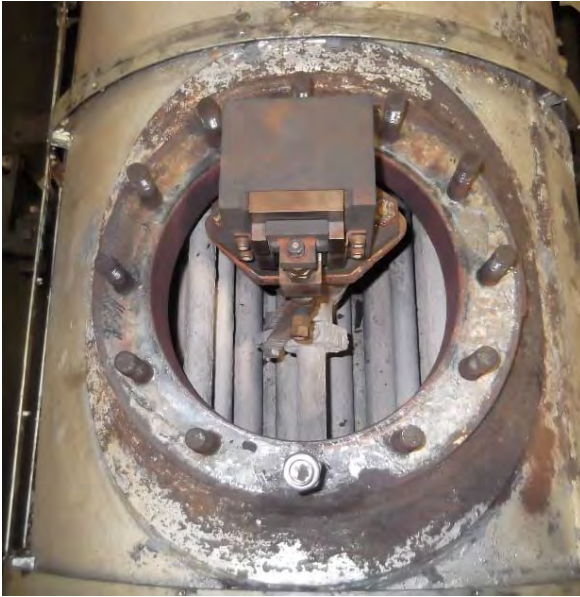
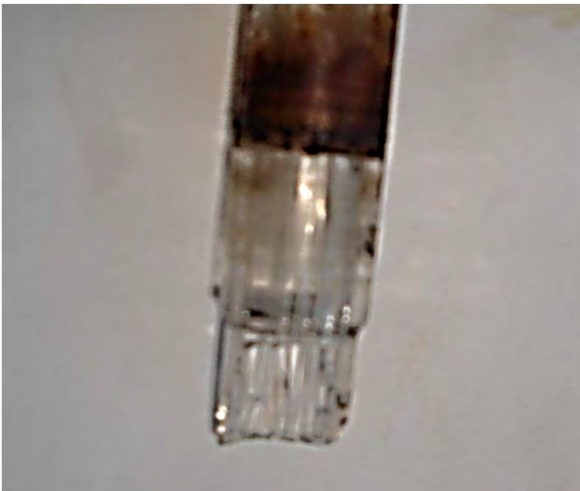
Improvements in water treatment has reduced boiler maintenance

- During the early years build up of scale and high fire temperatures led to high boiler costs: -
 - Routine washouts were frequent and foaming was endemic
 - Acid washouts were needed at intervals to remove scale
 - Fire tube life was typically only 1-2 seasons with cracks developing in both firebox tubeplate ligaments and tubes
- Changing the boiler treatment to a regime similar to that recommended by Porta has transformed the situation: -
 - Boilers remain clean internally (see view inside boiler of No.7)
 - Washouts are typically every 90 days
 - Tube life is extended enormously (No.9 has the original tubes after 20+ years)
 - However, the high ph of the boiler water does require regular changing of gauge glasses at 30 day intervals due to wasting (see photo) and inspection of the condition of threaded boiler fittings

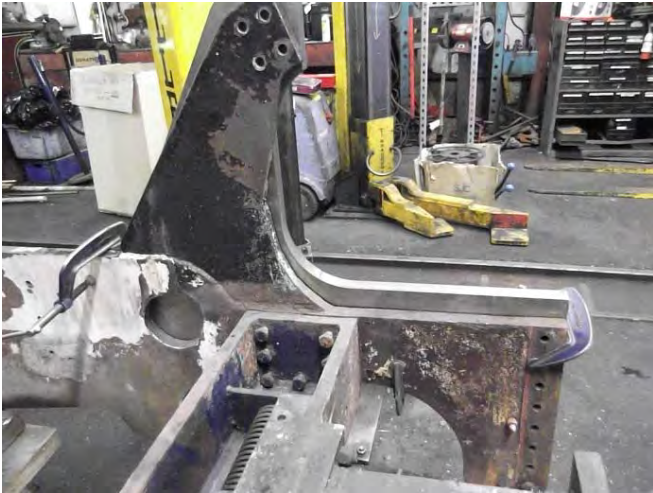
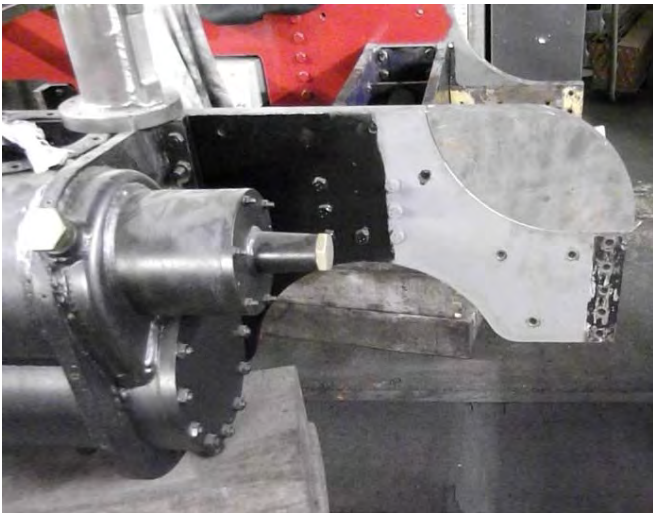
Frame strengthening and weight distribution improvement

- Strengthening and alteration of the front and rear of the frames has been undertaken where required for a number of reasons including: -
 - Weakness at washout plug access holes which were too close to frame edge
 - Repositioning of washout plug access holes
 - Reprofilng of cutout for front pony trucks when converting from inside to outside axle box design
 - Addition of weight to the front end of locomotive to improve weight distribution on the driving wheels e.g. thick buffer beams, thick smokeboxes, smoke deflector plates etc.

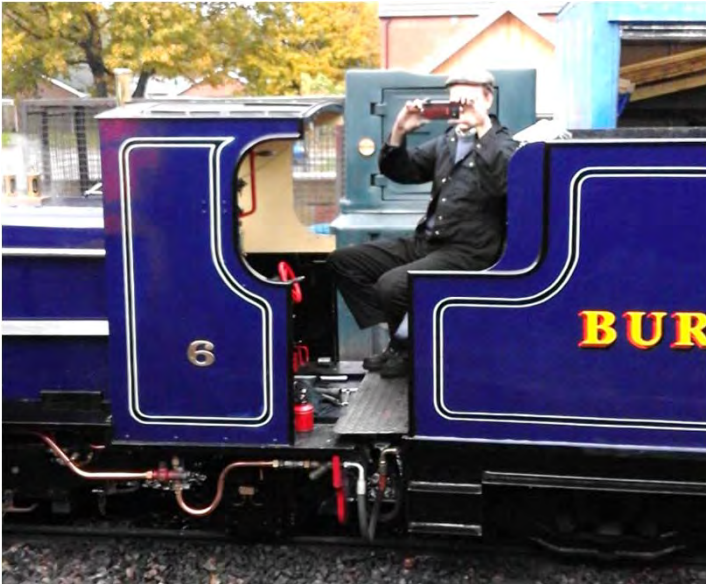
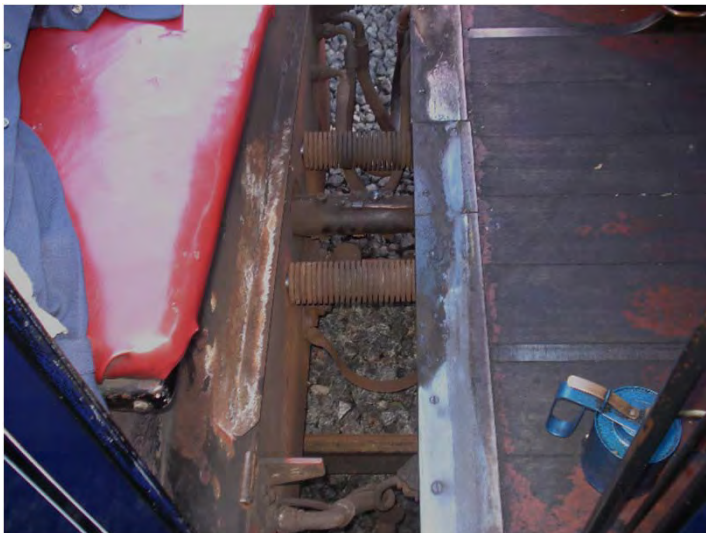
Improving crew safety on Nos 6 and 7

- The coupling between the loco and tender presented a hazard for crew in the event of failure
- To reduce this risk: -
 - The primary coupling was replaced with a better engineered unit having ball joints at each end
 - Twin emergency couplings with springs to absorb snatch if the main coupling fails are provided on either side
 - The fall plate mounting has now been moved from the loco to the tender to maintain a foot support for the crew at all times. In addition it is provided with supports to stop it falling down in the event that the main coupling has failed and the locomotive separates slightly

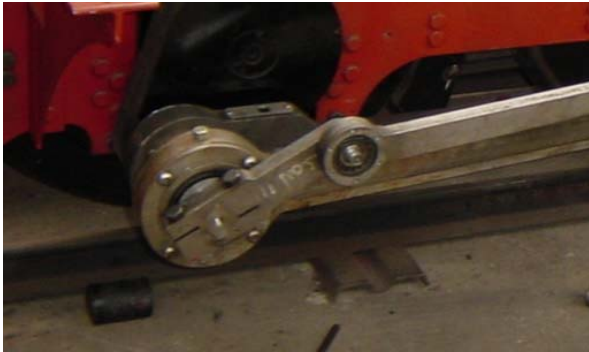
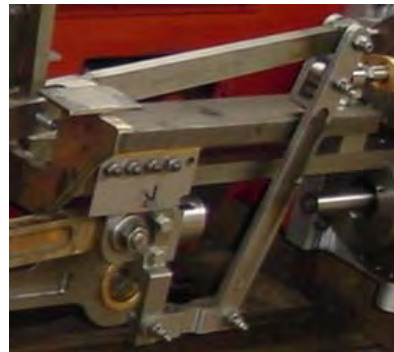
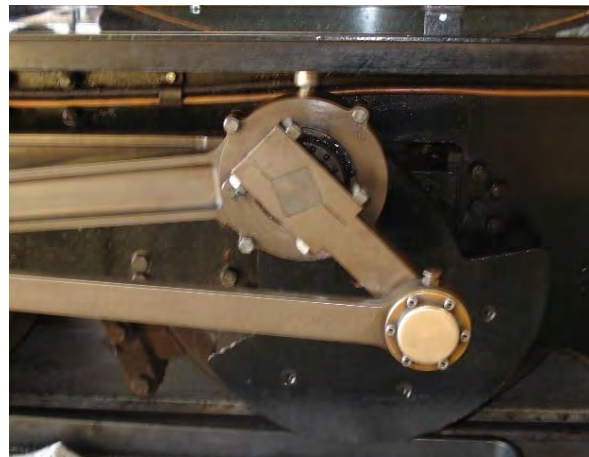
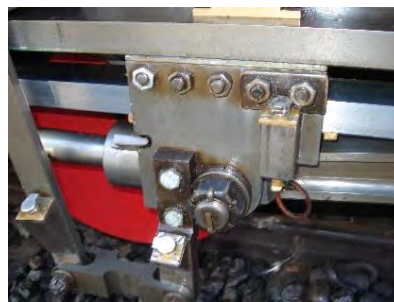
Redesign of the connecting rods and crossheads

- The original connecting rods and crossheads were unsatisfactory: -
 - The screw holes for the bearing clamp plates in the wall of the big end eye caused unacceptable stress raisers
 - The little end eye was overstressed and too narrow resulting in overloading and premature failure of the little end bush
- New connecting rods were designed in high tensile RQT701 with clamp screws outside the big end eye and wider little end eyes
- New wider crossheads were designed to suit the rods and improved securing of the little end pin with a taper collet was provided

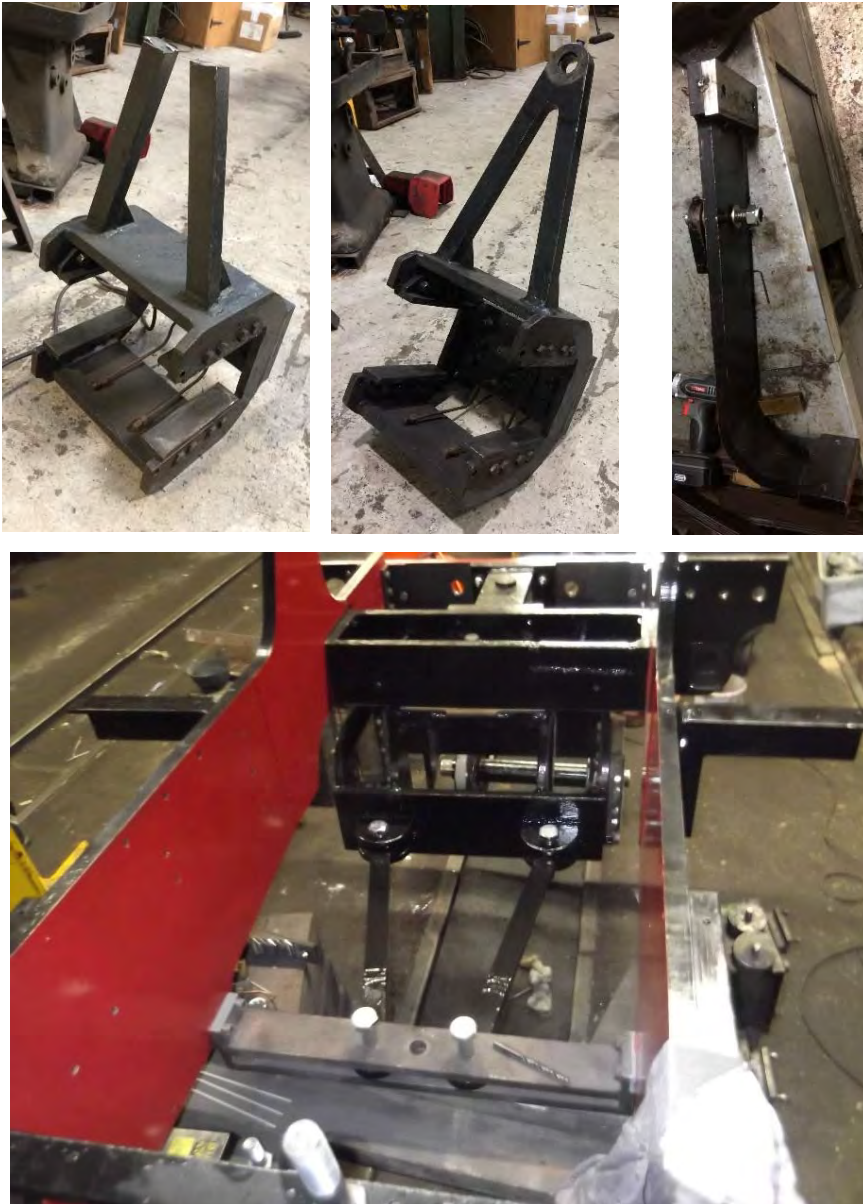
Geometry of pivot points of front and rear pony trucks corrected

- Excessive tyre wear on the front and rear pony trucks was found to have been caused by the pivot point being too close to the truck axle
- Revised pivot point positions were calculated and corrections made to the geometry as follows: -
 - The front trucks had the 'A' frame cut and extended and a new pivot was located on a new member spanning between the frame stretchers below the front driving axle
 - The rear trucks had the 'A' frame removed and were supported on two inclined swing links attached to the original pivot stretcher such that the centre lines passed through the virtual pivot point. This corrected the geometry while avoiding the boiler firebox
