FINAL YEAR PROJECT

Austerity 90733

Locomotive Horn guide and Frame Re-design

B.Eng. (Hons) Mechanical Engineering

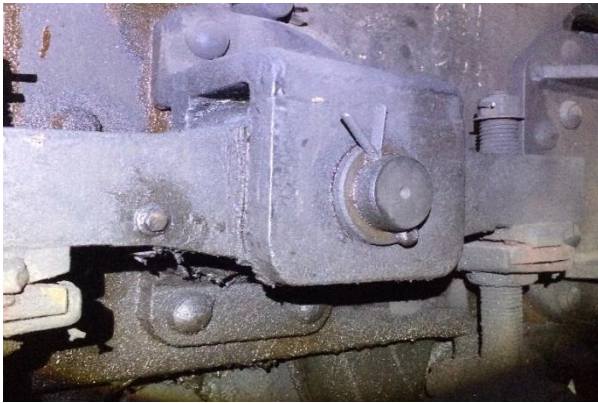
Figure 7 spring hanger bracket (Kay,2017)

Figure 7 displays the compensating spring bracket. The springs are attached via a rotating bar allowed to pivot around a central shaft fixed through the bracket. This system allows an equal distribution of the static weight applied when stationary and dynamic weight when the locomotive is negotiating undulating track work.

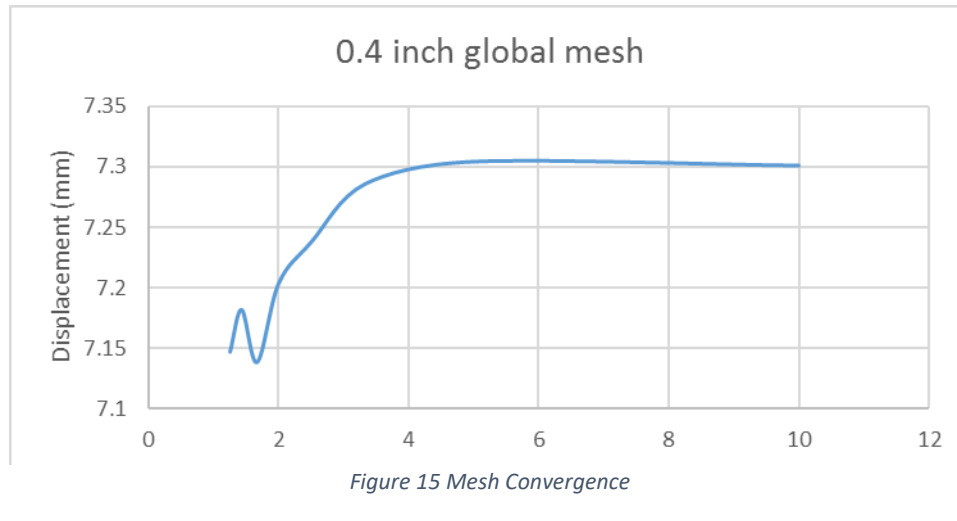
As shown in table 1 and figure 15 a global mesh of 4 inch and a mesh control size of 0.2 inches produce a convergence. Therefore these values will be used for the each of the following simulations to determine the displacements on the 2-8-0's frame.
