# Electronic Locomotive Indicating trials by ASTS Ltd

# Instrumentation targets

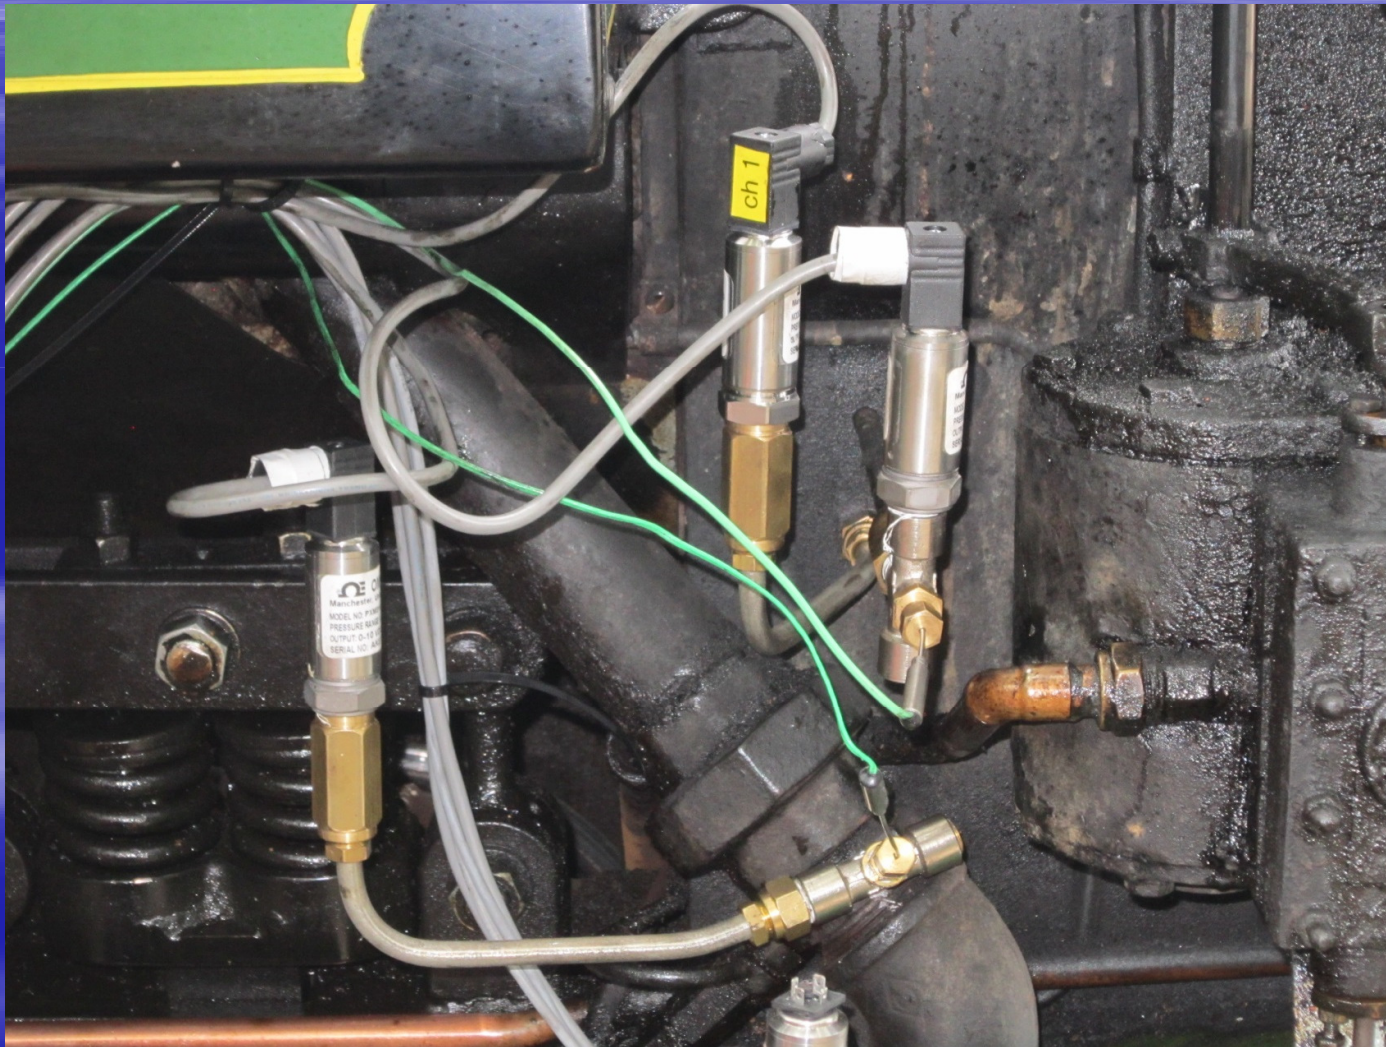
## Original fit

# Badger Instrumentation

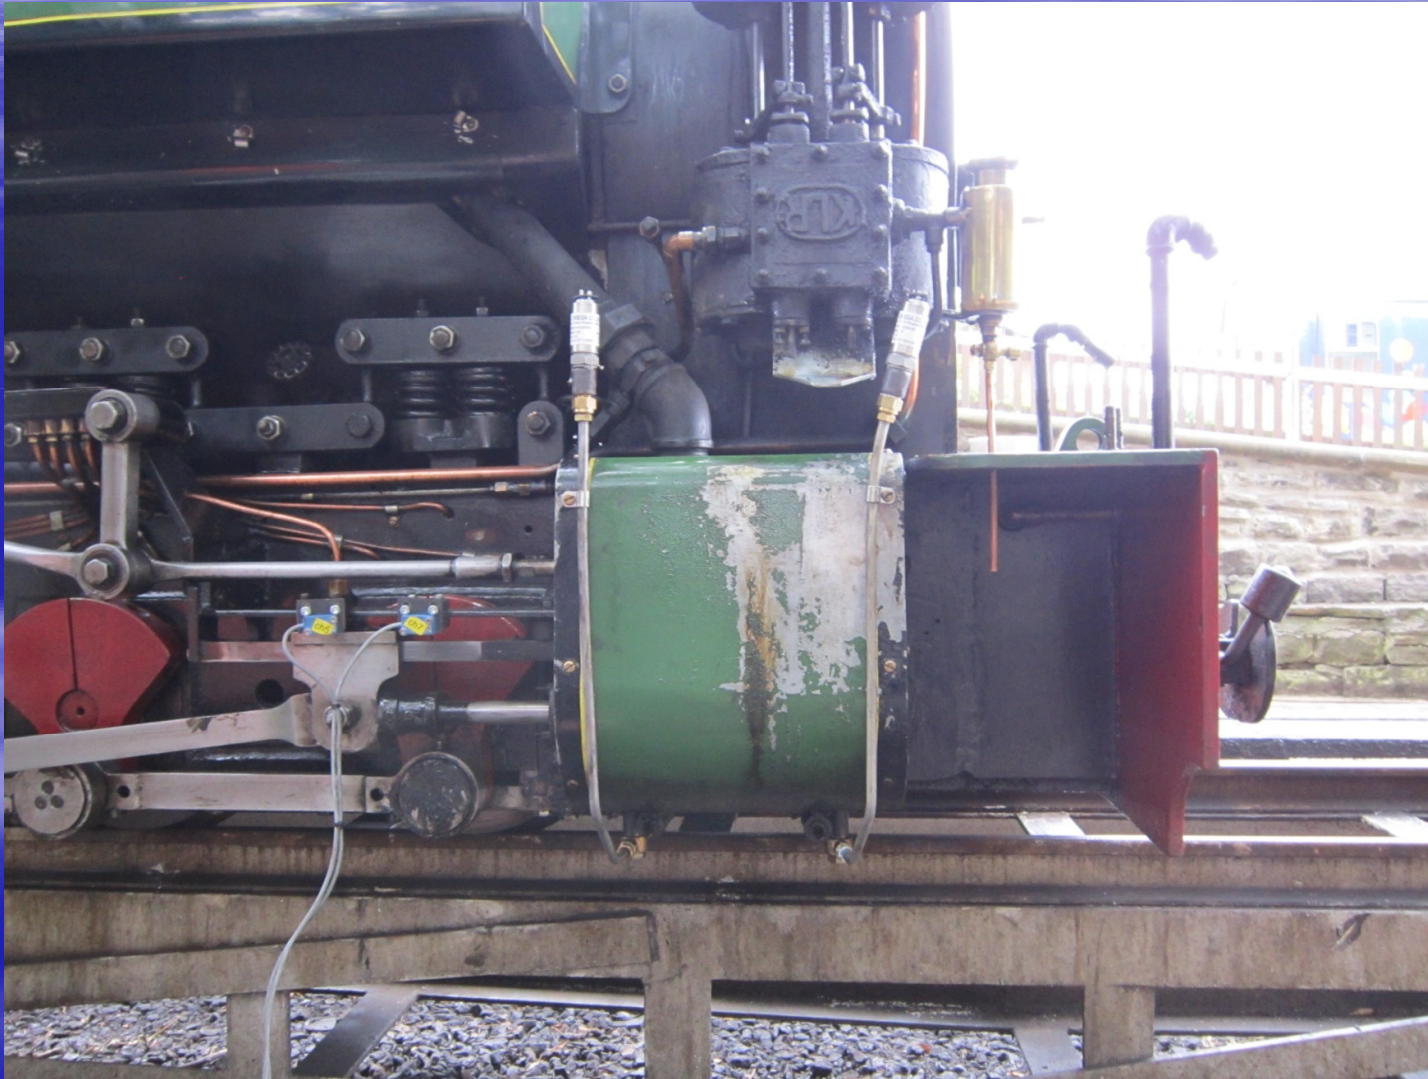
## Original fit

# Badger Instrumentation

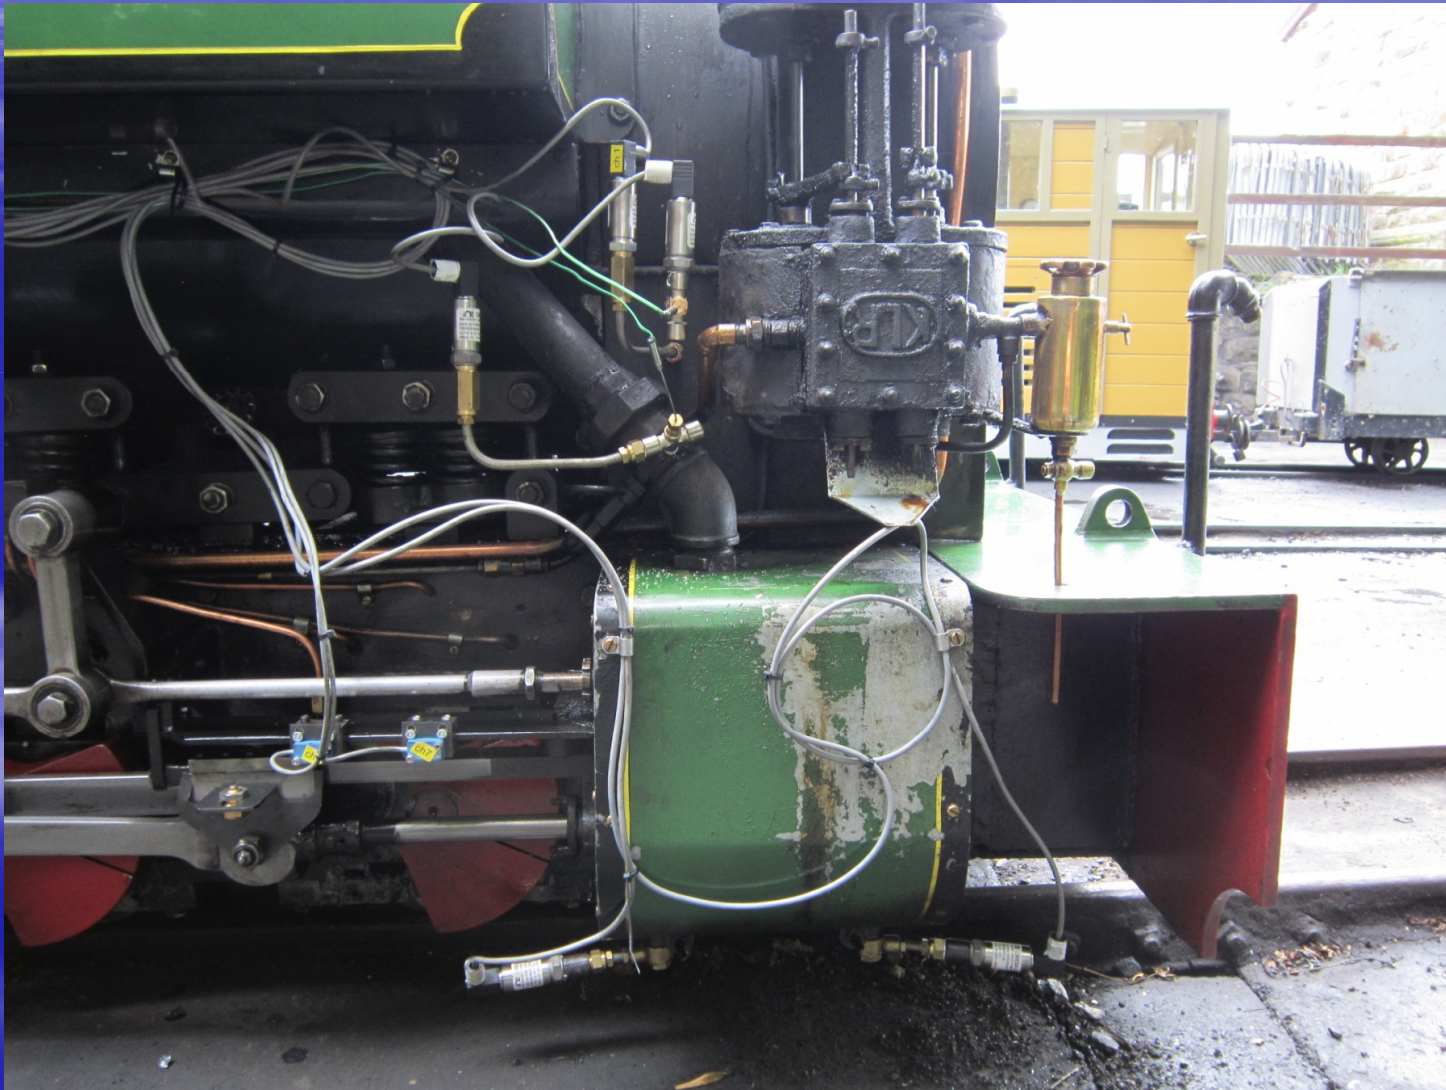
## Full second fit

# Badger Instrumentation

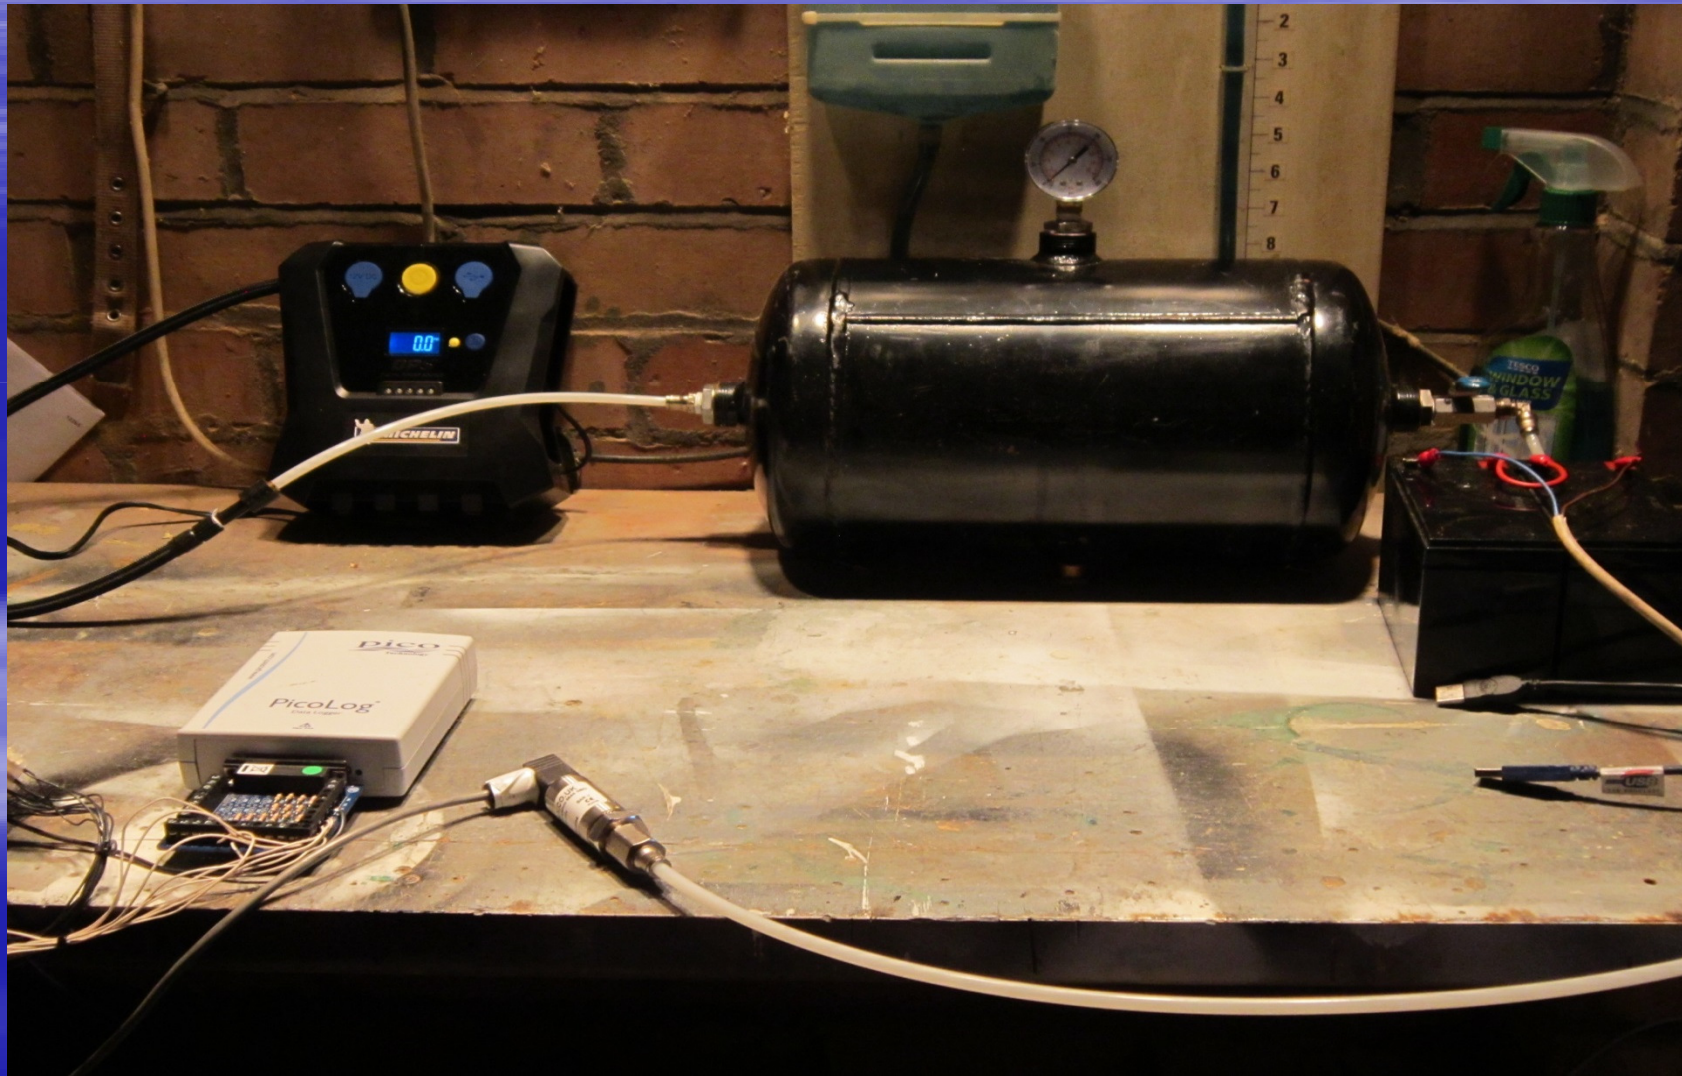
# Badger Instrumentation Pressure testing

The pressure transducers were checked against a pressure gauge with known calibration of  $\pm 1\%$  which is accurate enough for our purposes.

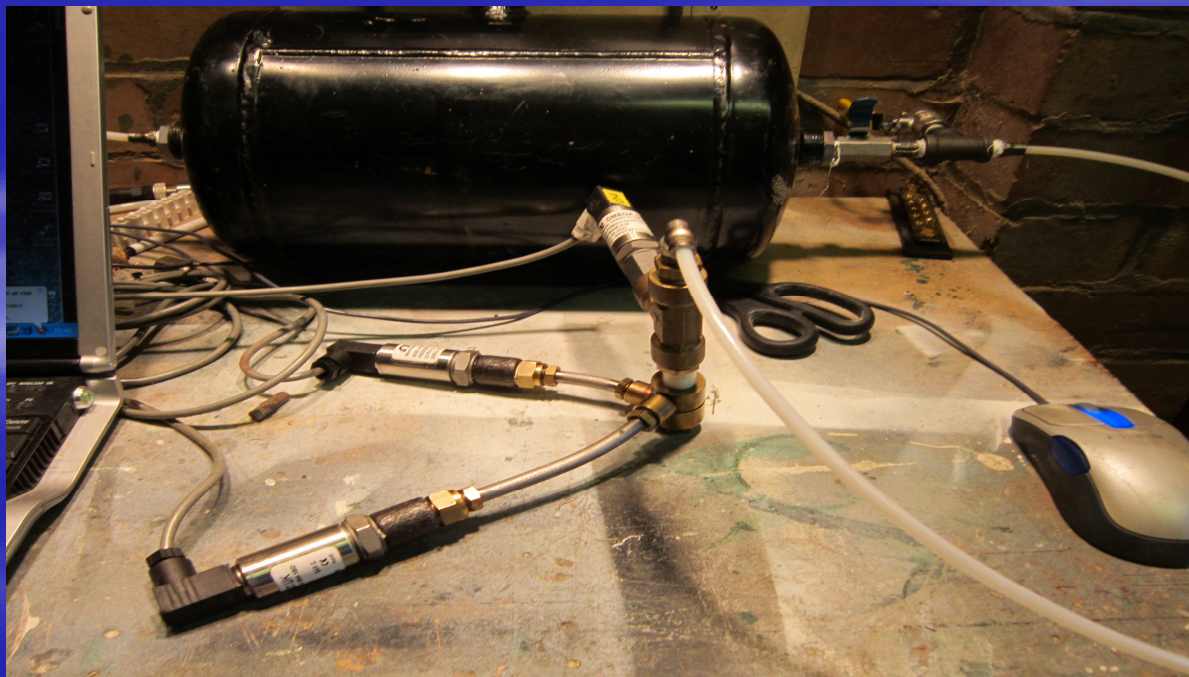
A jig was devised to allow direct comparison after a test run between the three pressure transducers to confirm test run results

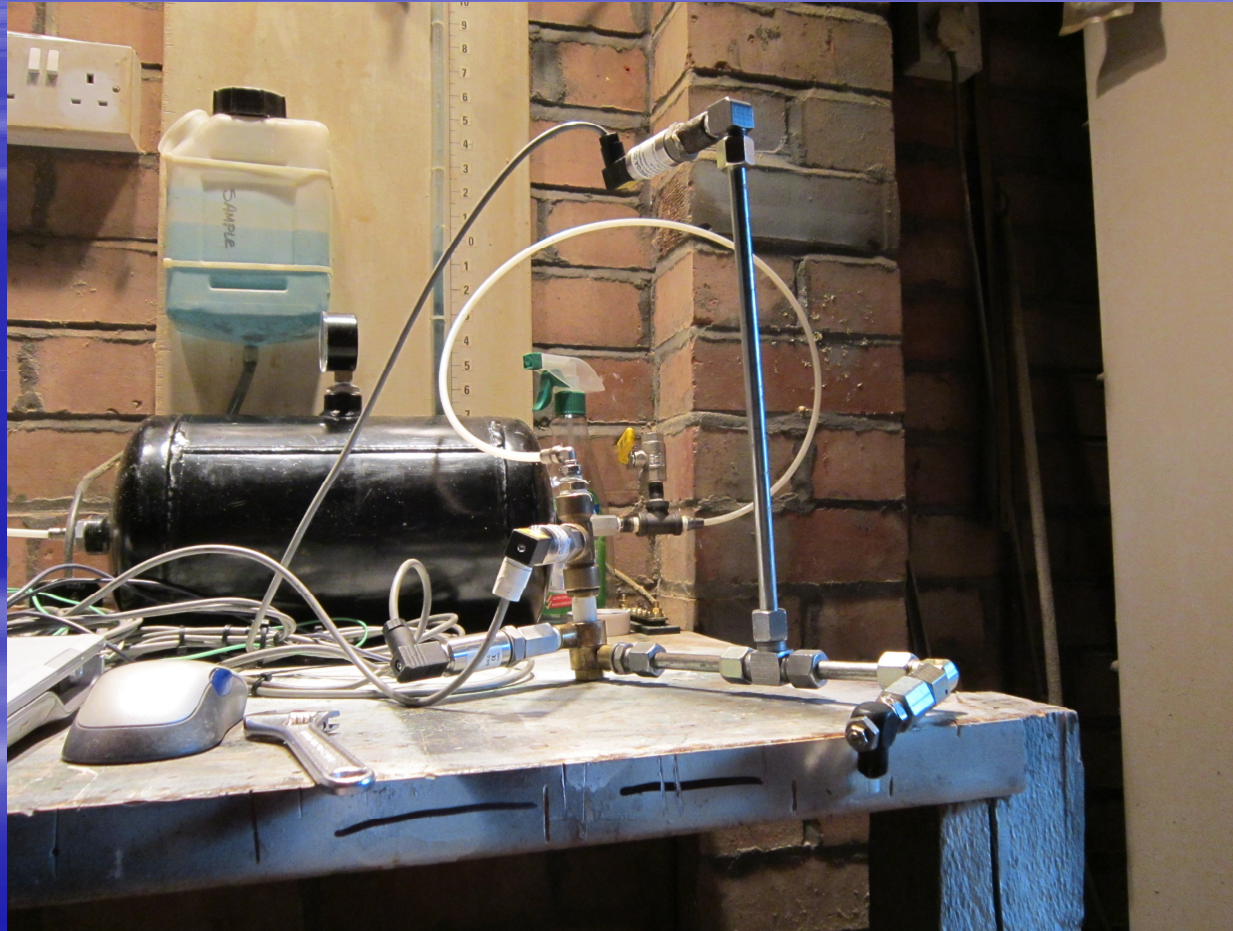
# The first attempt at a useable solution

A small adjustable and lockable bleed valve was found which, together with modified pipework to ensure that water went to the bleed valve and not to the transducer provided the answer

The bleed is adjusted firstly on the test rig and then on the loco to set the bleed so that water comes out and is followed by the tiniest wisp of steam

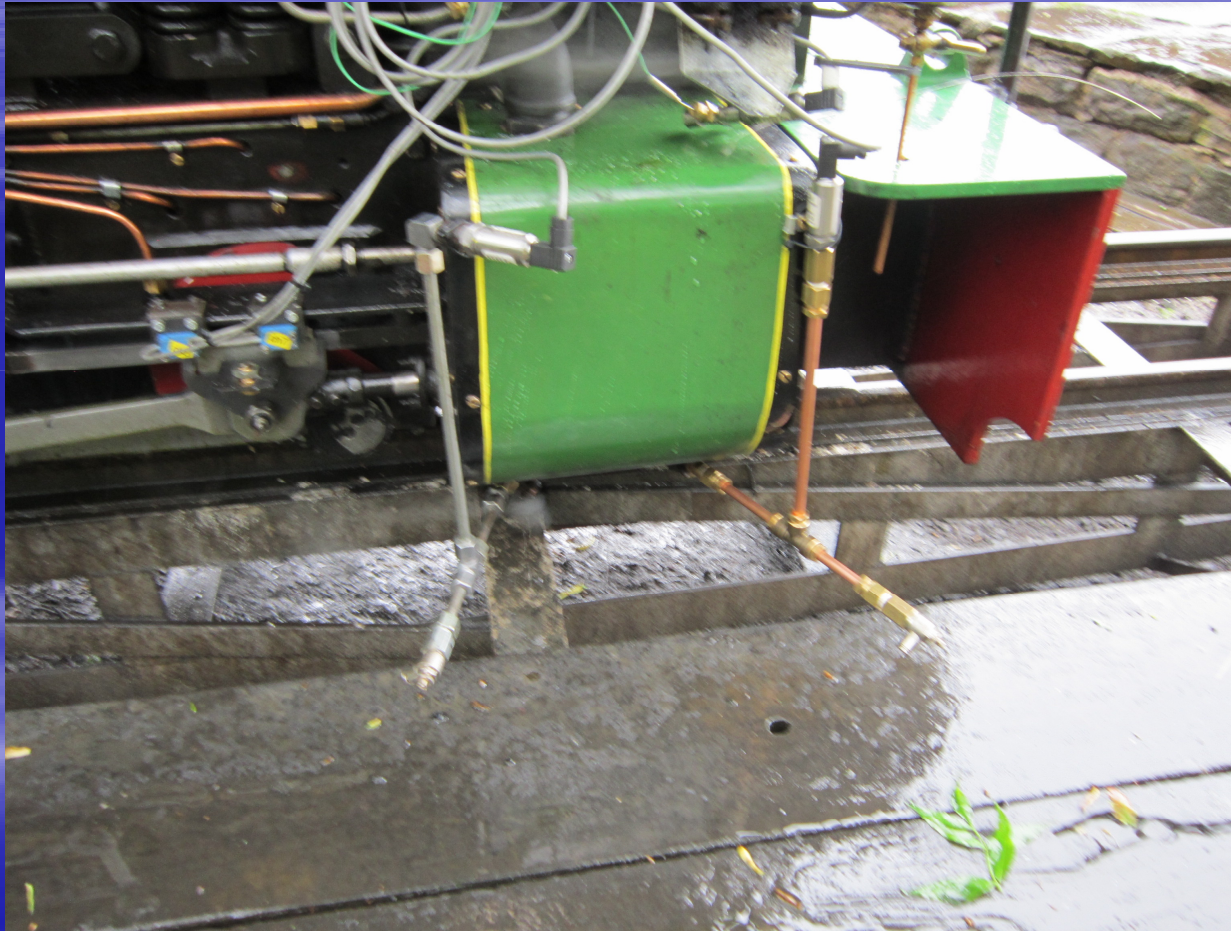
# New solution fitted to Badger

This ensures that water is continuously bled from the system and that the transducer is also far enough away to keep it cool and away from the water
