The Development of the Bure Valley Railway ZB Class

Ian Gaylor
Robert King

Rev.1
Date 4.10.22.

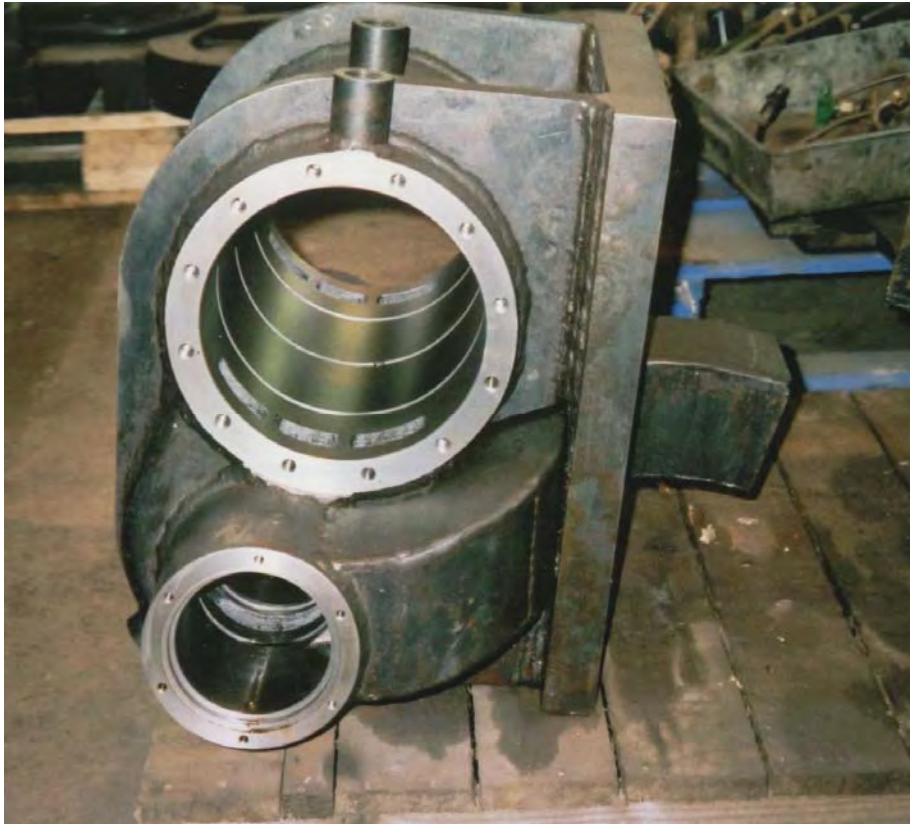
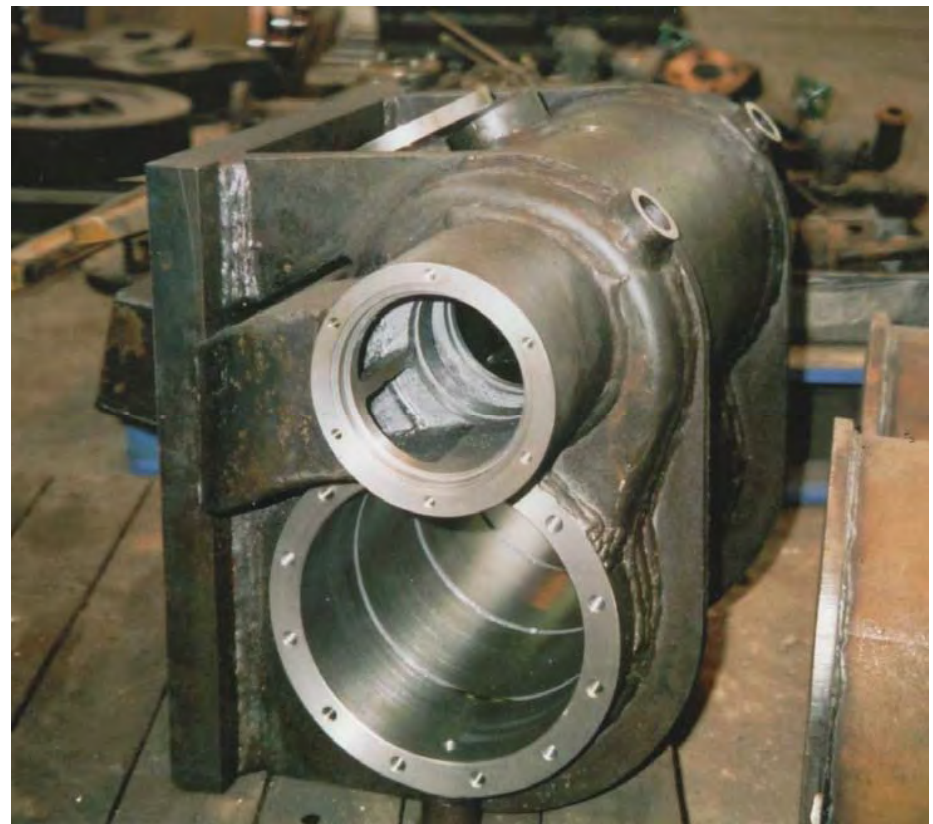
The size of the passageways on the new cylinders is apparent

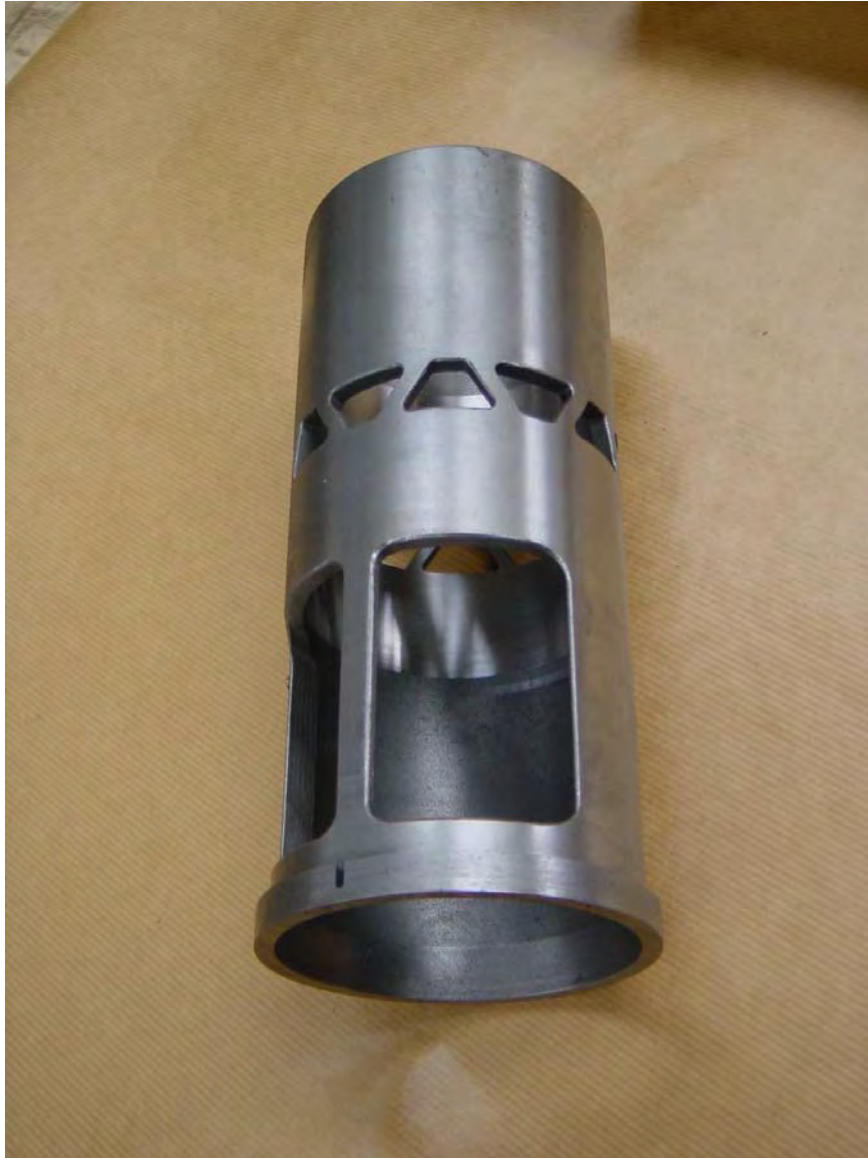
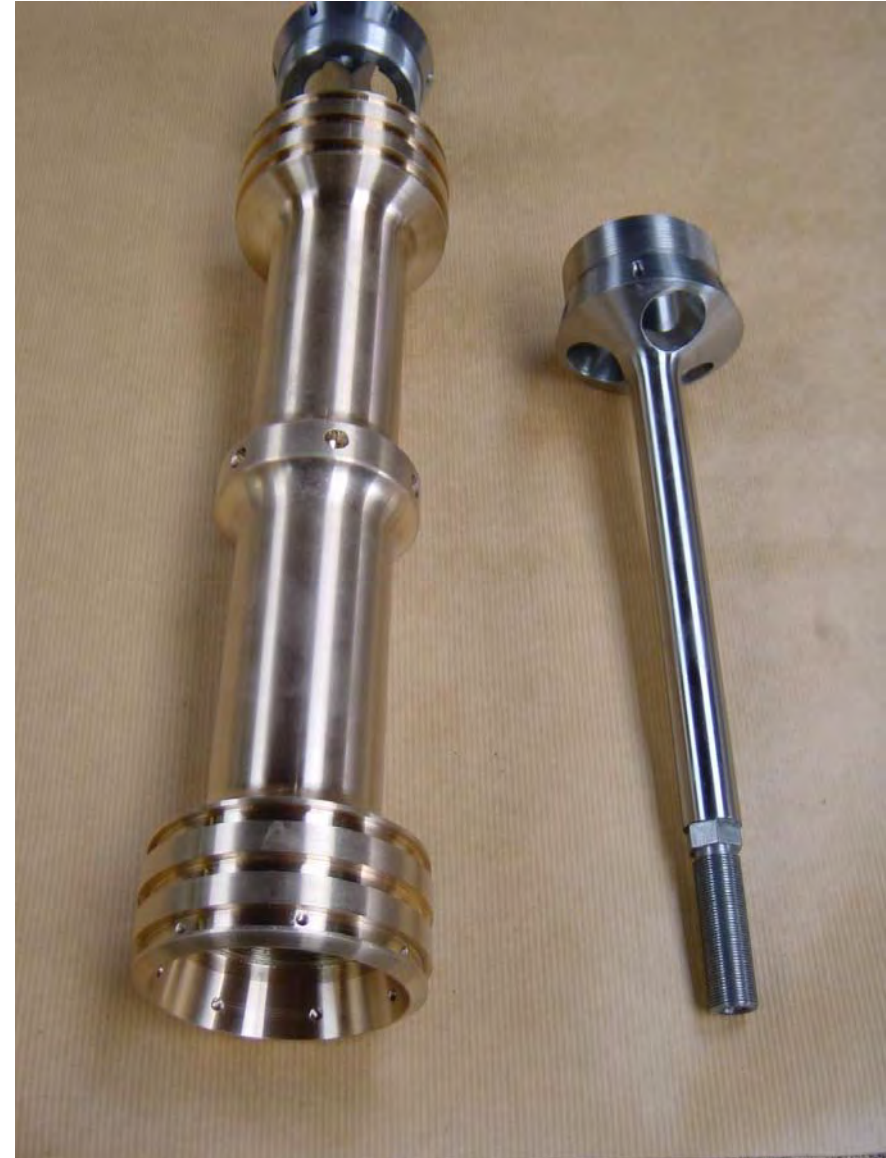
Split valve liner and hollow bronze valve head with stainless steel valve rod

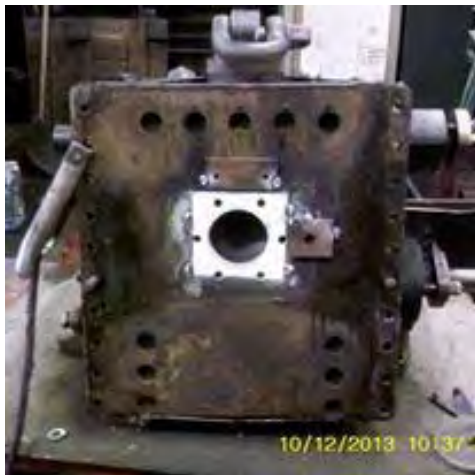
The original cylinders on Nos. 7 & 8 restricted the steam flow

- The steam chest inlet, transfer ports and exhaust ports were restricted
- Steam chest volume was only 10.1% of cylinder swept volume

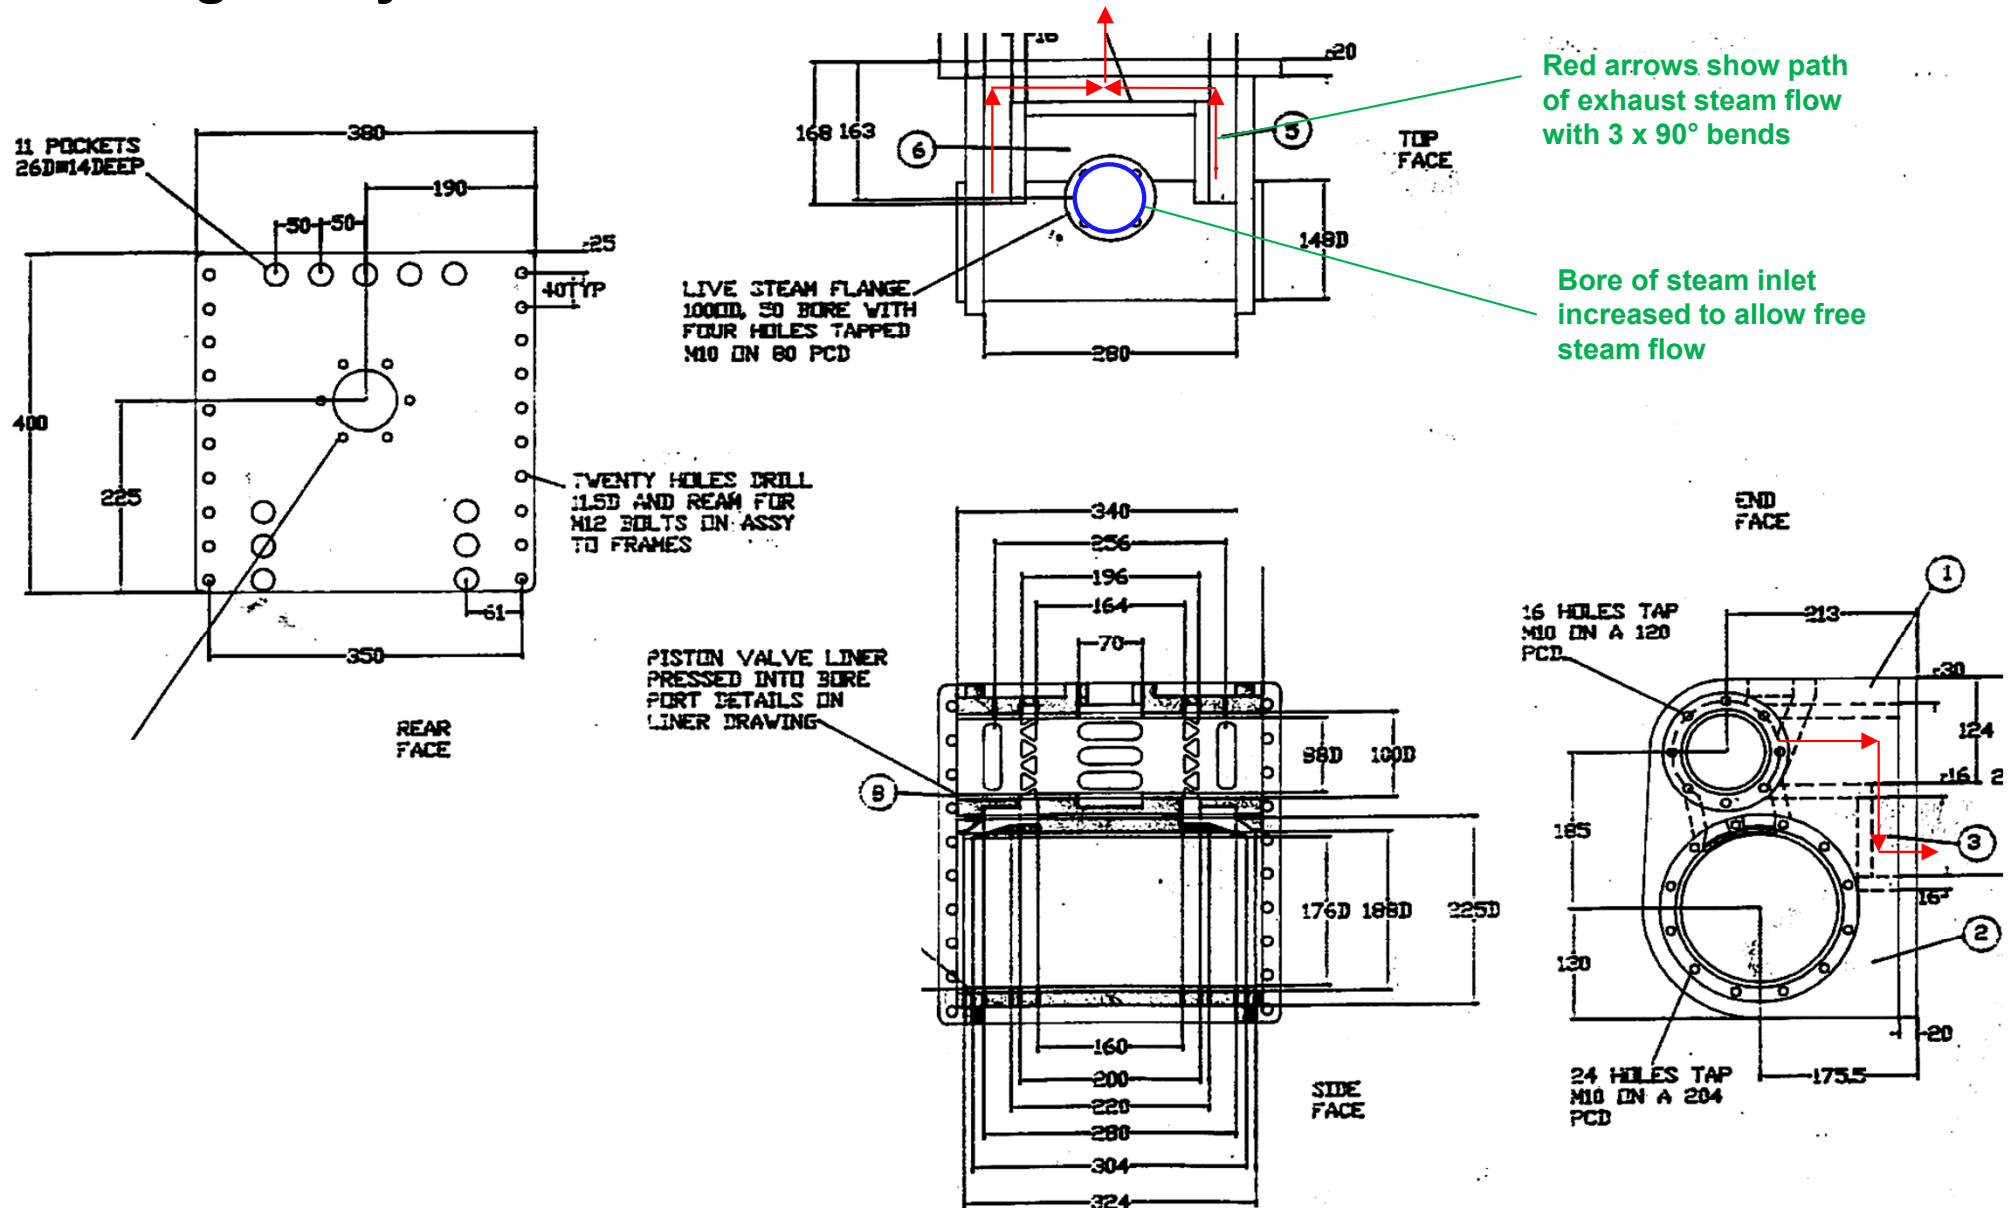
The original cylinders on Nos. 7 & 8 restricted the steam flow

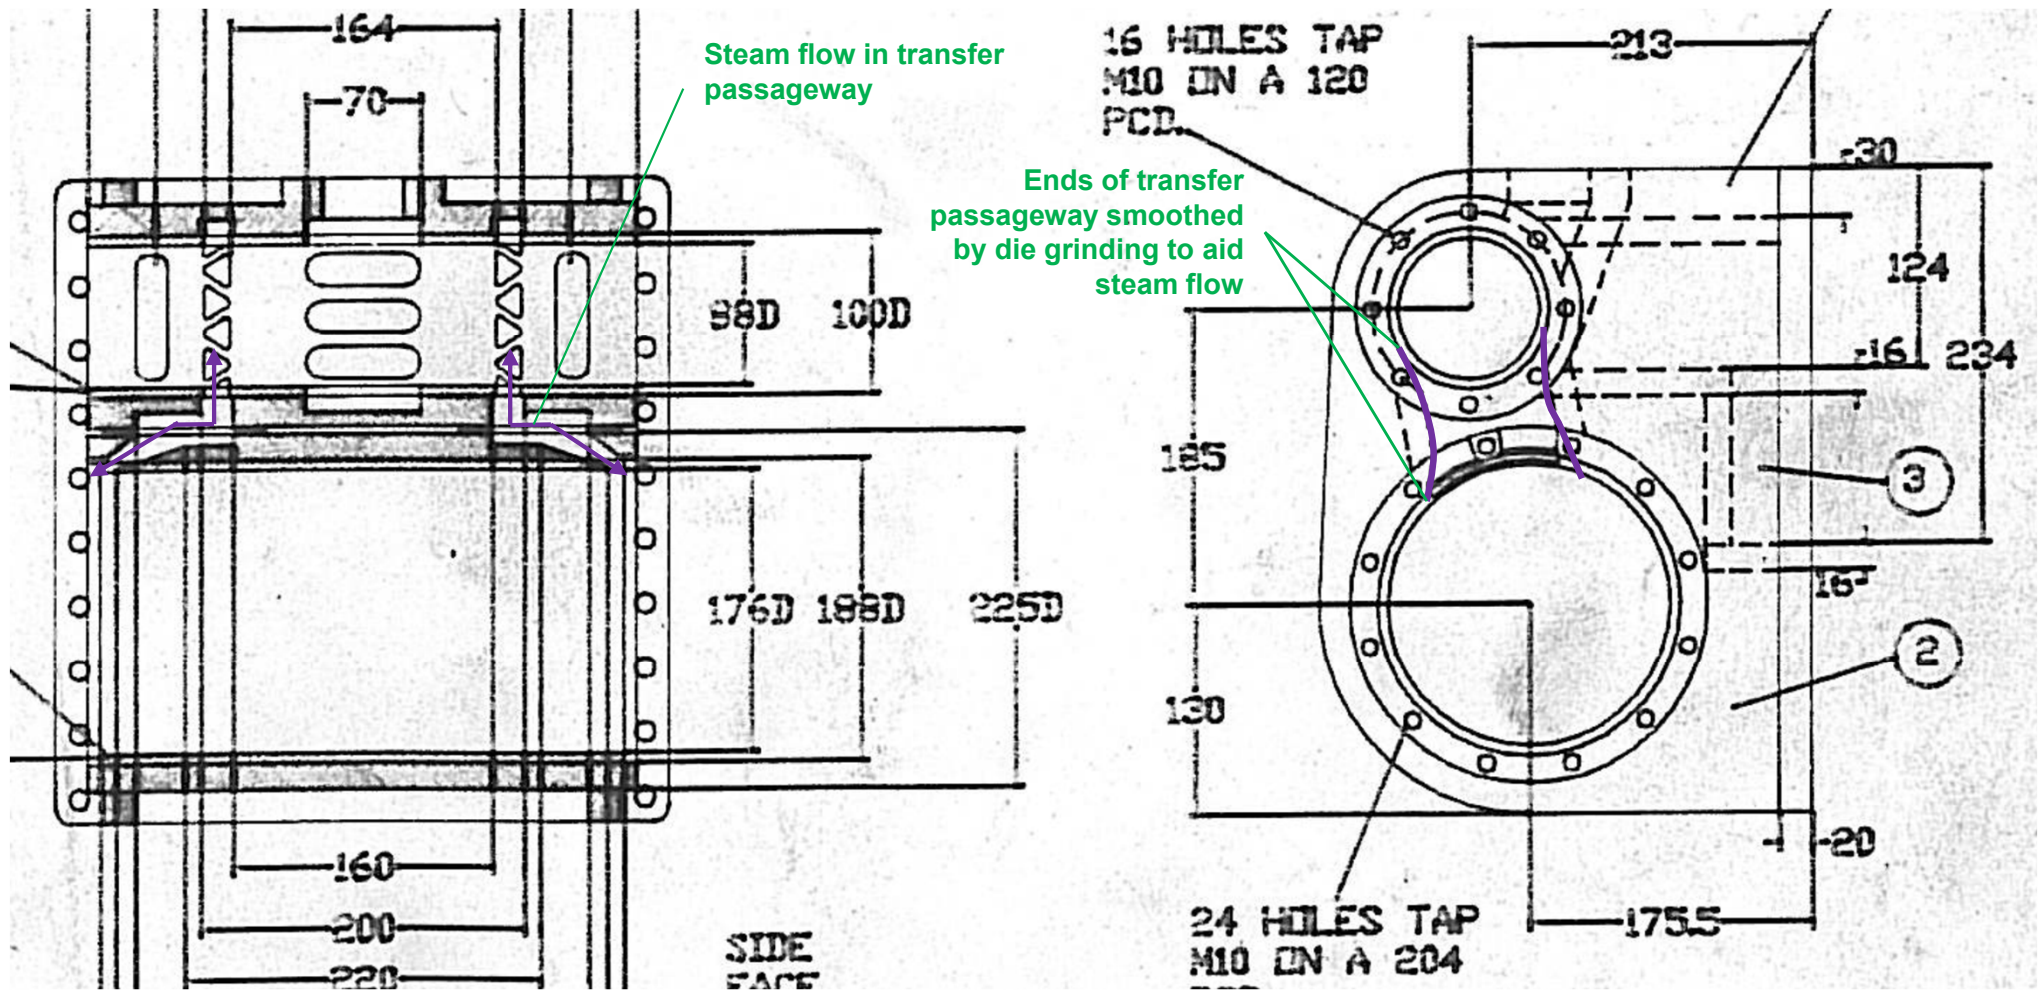
The original cylinders on Nos. 7 & 8 restricted the steam flow

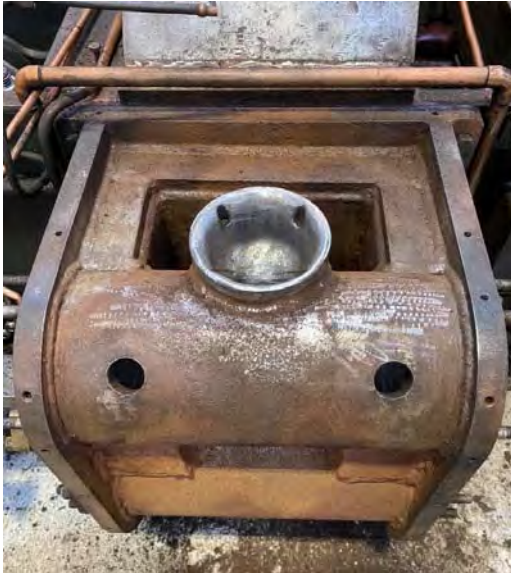
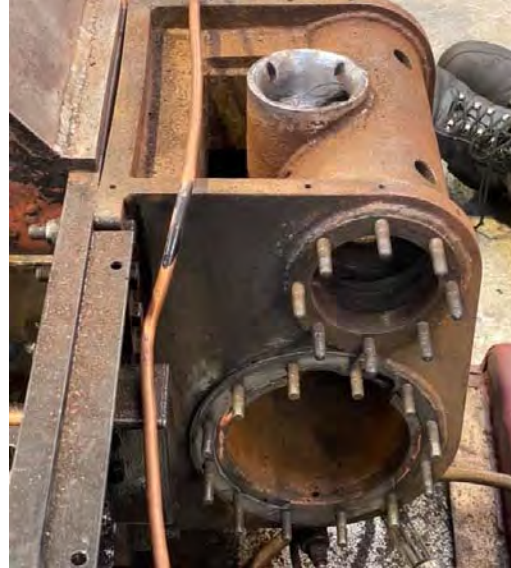
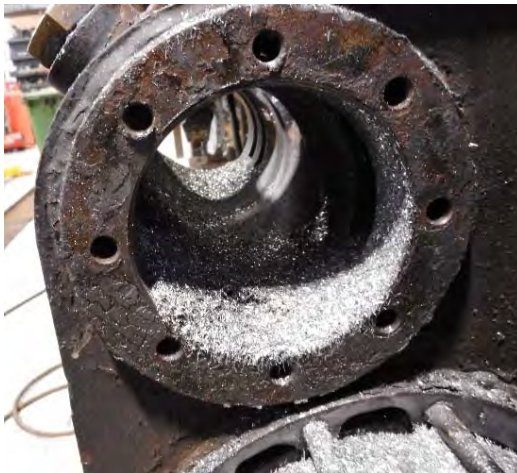
The original cylinders on Nos. 7 & 8 were improved

- The cylinders were probably designed for ease of manufacture and steam flow has not been optimised
- The cylinders were not stress relieved before machining when manufactured and are therefore prone to distortion (see joint with mainframe)
- Steam chest inlet and transfer ports were opened up by die grinding to increase steam flow however the transfer passageways remain 'Z' shaped
- Steam chest volume was increased by welding on large diameter pipe fittings in order to ensure a full indicator diagram at speed
- The exhaust ports remain restricted as the steam has to pass around 3 x 90° bends before reaching the pipe to the exhaust stand

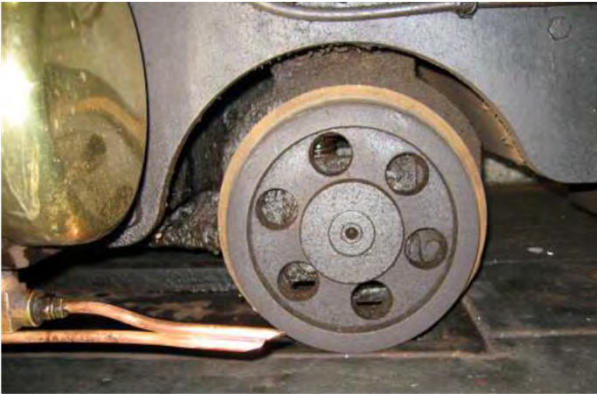
Suspension improvements

- The front pony trucks on Nos 6,7,and 8 were originally of inside frame design supported on twin die springs (see photo)
- The design was hard to inspect and maintain compared to the final outside frame arrangement provided on No.9
- A transition to outside frames is being implemented at heavy overhauls requiring extensive rebuilding of the pony truck and some main frame modification to provide clearance (see photo)
- Main spring design has been improved and a 'Universal' spring pack utilising a larger number of thinner leaves to maintain the spring rate but increase fatigue life is used for all locos

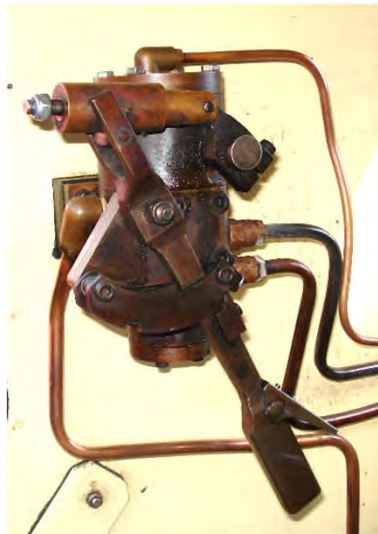
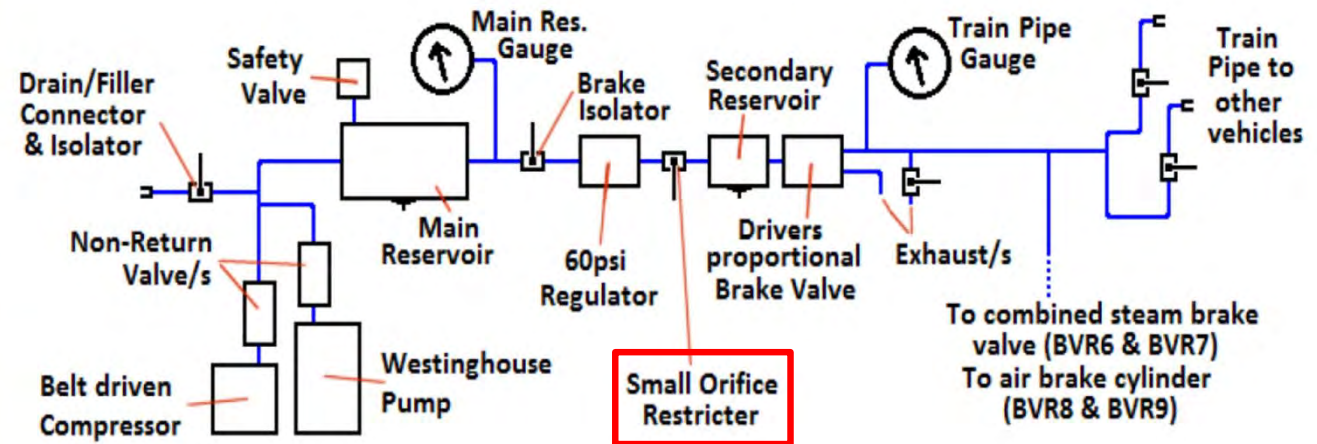
Braking installation on locomotives

- The locomotives all have steam brakes operating on the driving wheels and Westinghouse style automatic single line air brakes which act on the driving wheels for the tank locomotives and the tender wheels for Nos 6 & 7

- Functional improvements to the double acting Westinghouse pumps were made and applied to all the locomotives (see photo)
- Concerns about braking performance and efficacy of the Guards' emergency brake led to a number of upgrades in conjunction with HMRI: -

- A small orifice restrictor (highlighted in red on the diagram above) was added to prevent the air stored in the locomotive main reservoir overcoming the Guards' emergency brake or failure of the train pipe

- The hysteresis of the triple valves was reduced to increase the maximum brake pressure applied by the cylinders
 - A drivers' steam brake valve was fitted to Nos. 6 & 7 which was also actuated by train pipe pressure to increase braking in order to compensate for the high locomotive weight (see photo)

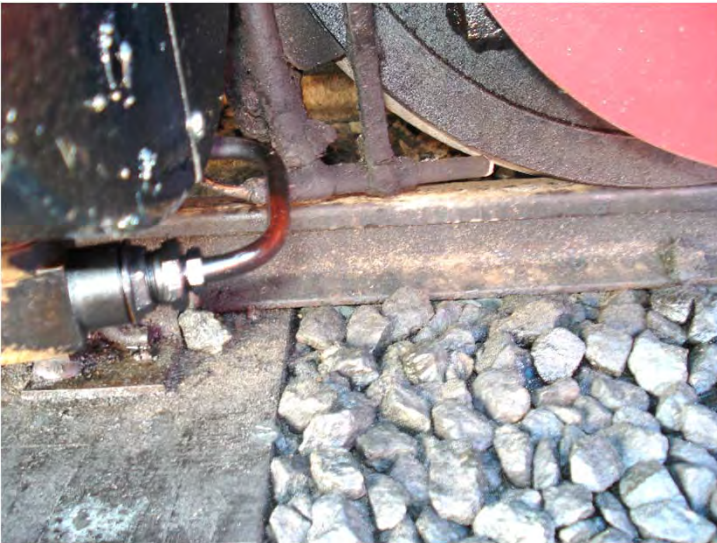
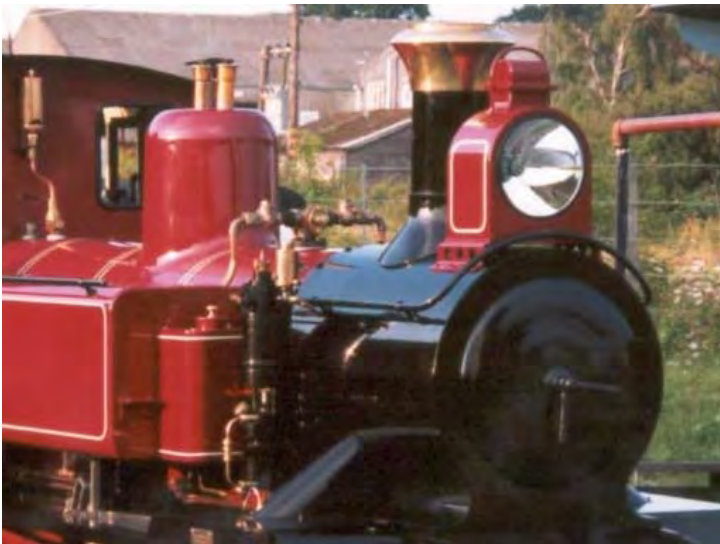
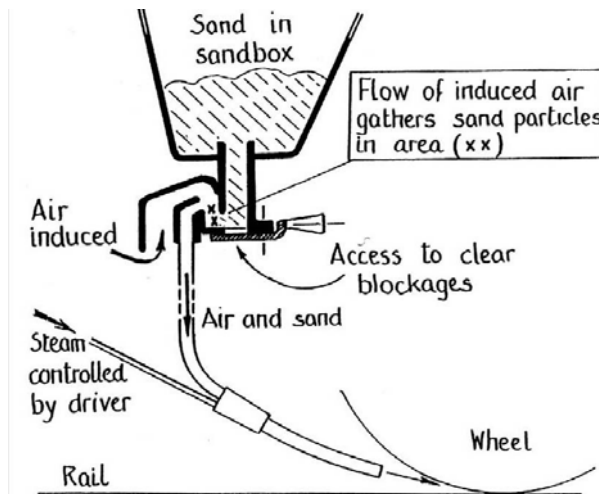
Addition of steam sanders

- Originally the locomotives had no sanding equipment leading to double heading or delays during adverse weather conditions
- Steam sanders working on the principle illustrated below were added to all the locomotives with sand boxes located in convenient positions close to the boiler where possible (see photos)
- Rubber hose is used for the connection between the box and sander to enable blockages to be dislodged by flexing the pipe

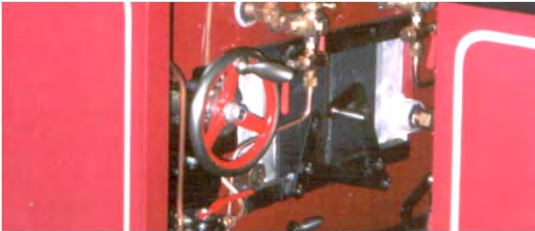
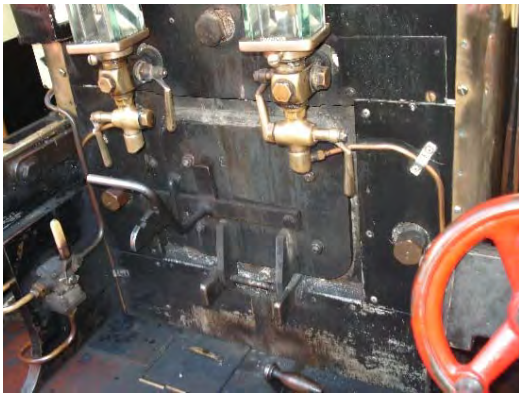
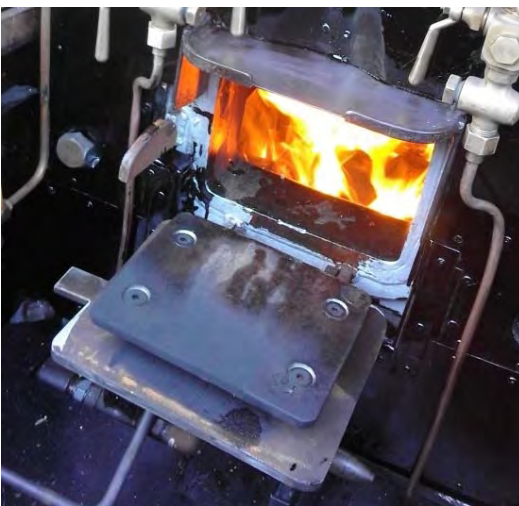
Fire doors and deflector plates

- The locomotives were fitted with brick arches cast in refractory concrete from new
- Subsequently deflector plates were added to enable the admission of a small amount of secondary air to reduce smoke in stations and when coasting without risk of damaging the tubes
- The original sliding fire doors 'clank' under the pulsations of the Lempor exhaust which is irritating for crew and gapping the door to control smoke creates an airflow direction which is sub-optimal
- The progressive change to drop down doors stops 'clanking' when pulling and when opened on the catch to admit secondary air the deflector plate and internal door baffle guide the air down towards the fire
